How to handle the charging detection failure of the Domino white ink machine?

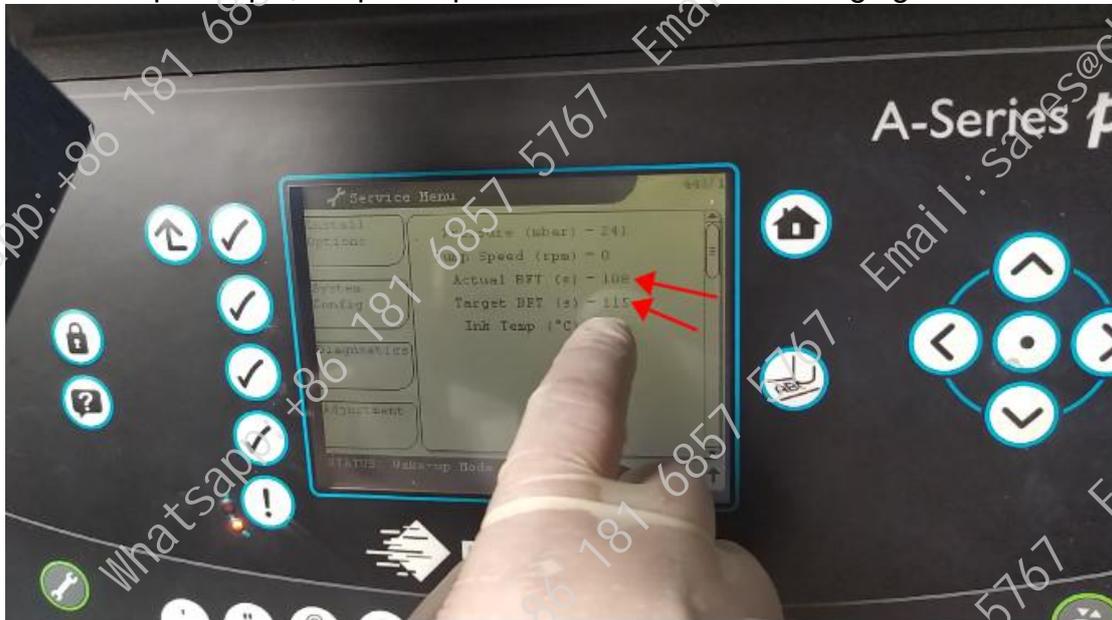
We need to see if the actual value of viscosity and the target value is very different, if the difference is very large, the viscosity is abnormal, easy to lead to bad ink point split, ink point split bad will lead to bad charging:

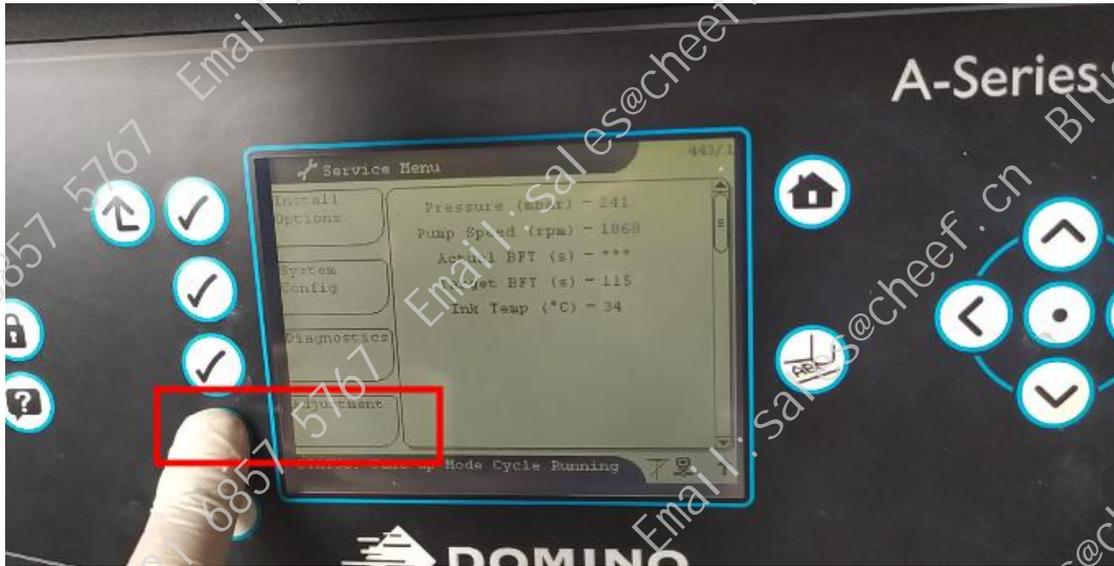
Another is that if the viscosity is normal, but the ink point split is not good, we have to choose "adjustment":

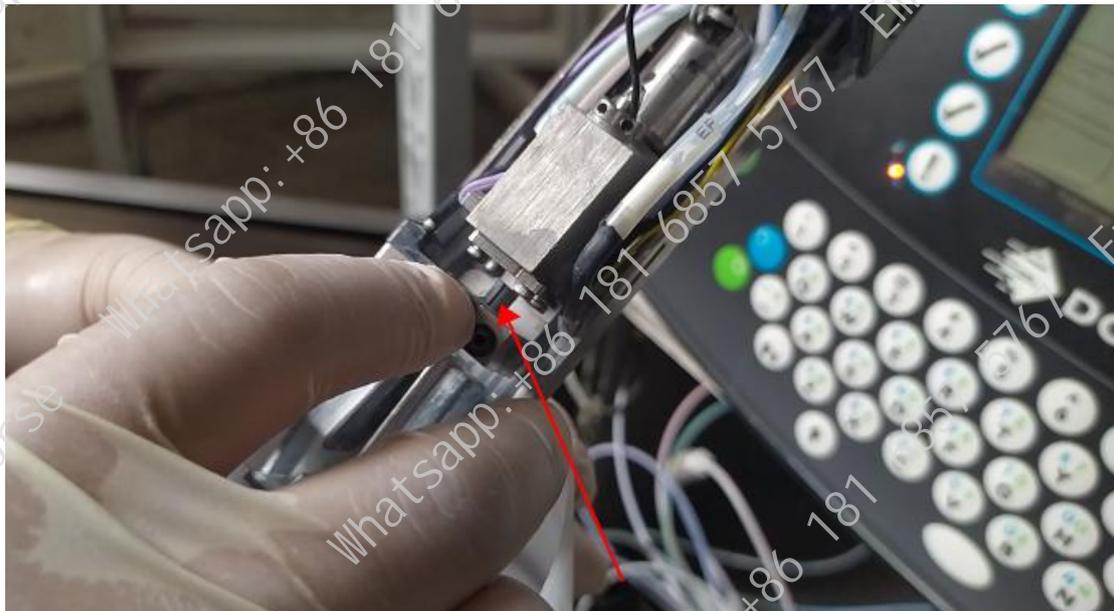
Let's see if this ink point splits well, if we turn on, we'll look at this position with a magnifying glass, look at this gap, see if it's good to split the ink dot:

It's good that we can see at least four dots.
