## How to unblock the straw of the print head of the IMAJE 9040 inkjet printer?

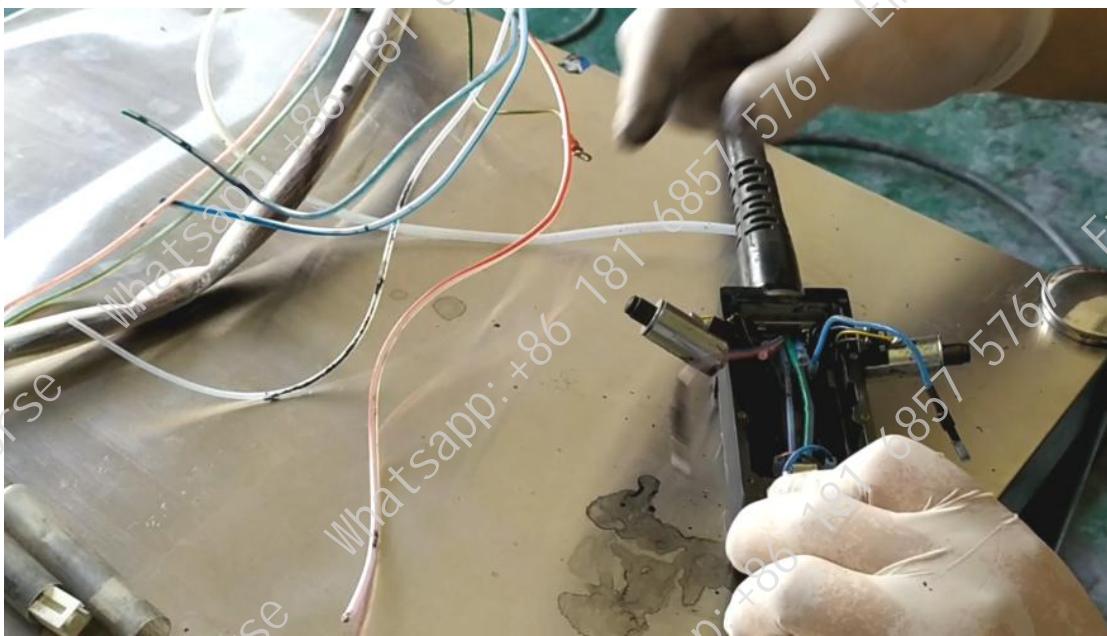
Then pry up another solenoid valve:

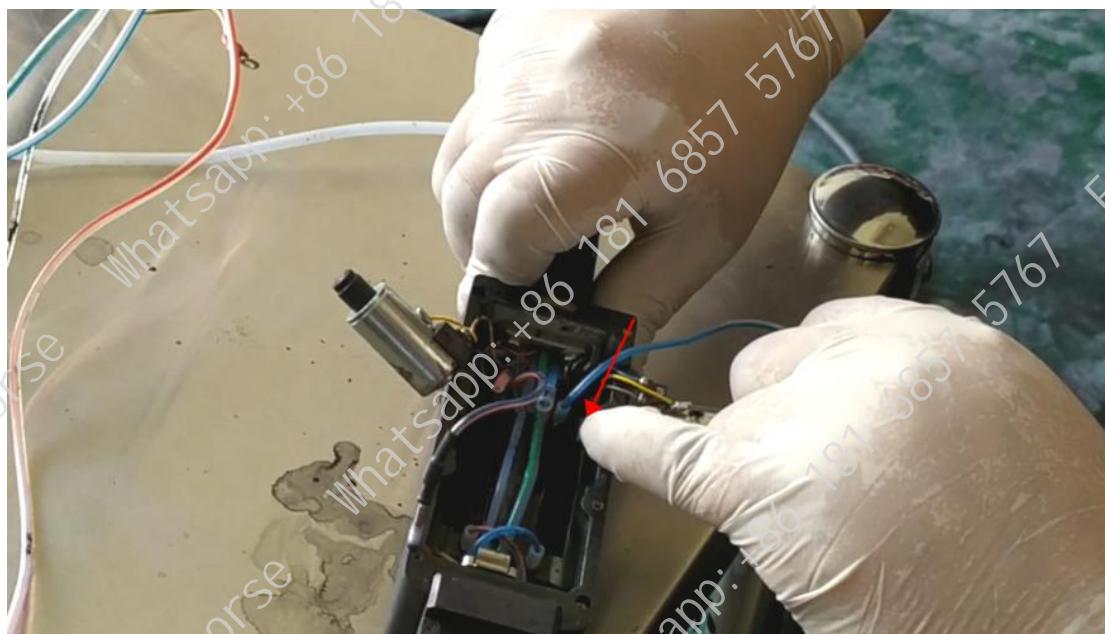
Then, cleaning fluid will come out at the rear end of the solenoid valve, which means that the straw is unblocked:

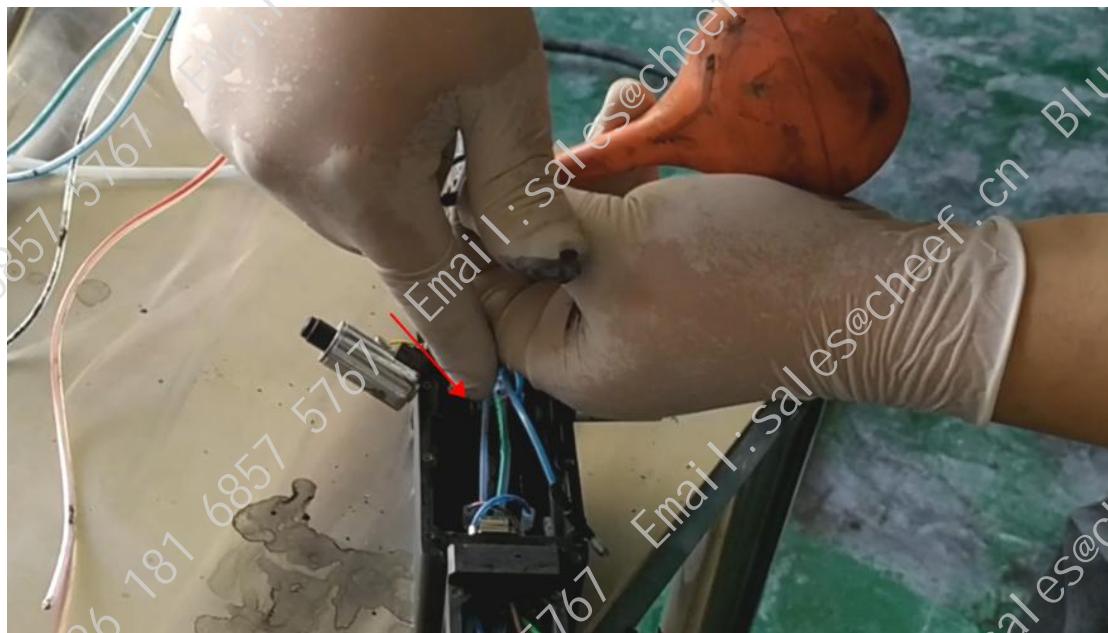
Then insert it into one end of the ink supply pipe, and the cleaning solution will come out after blowing, indicating that the suction pipe is also unobstructed:

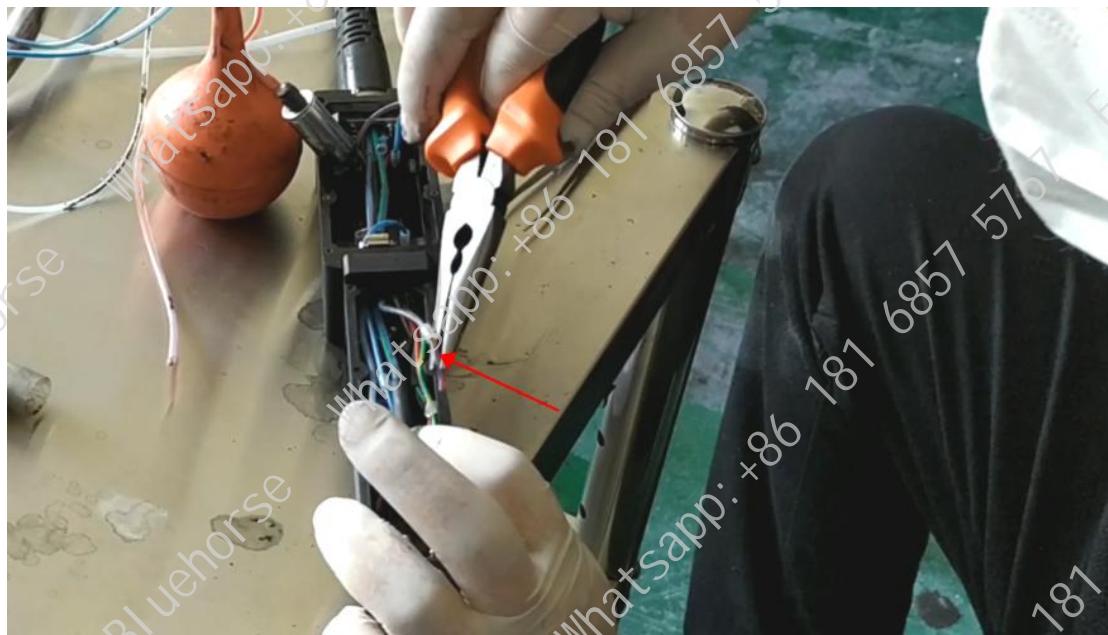
We can clamp these two straws with pointed nose pliers and pull them out.  
Pull out the ink supply pipe:

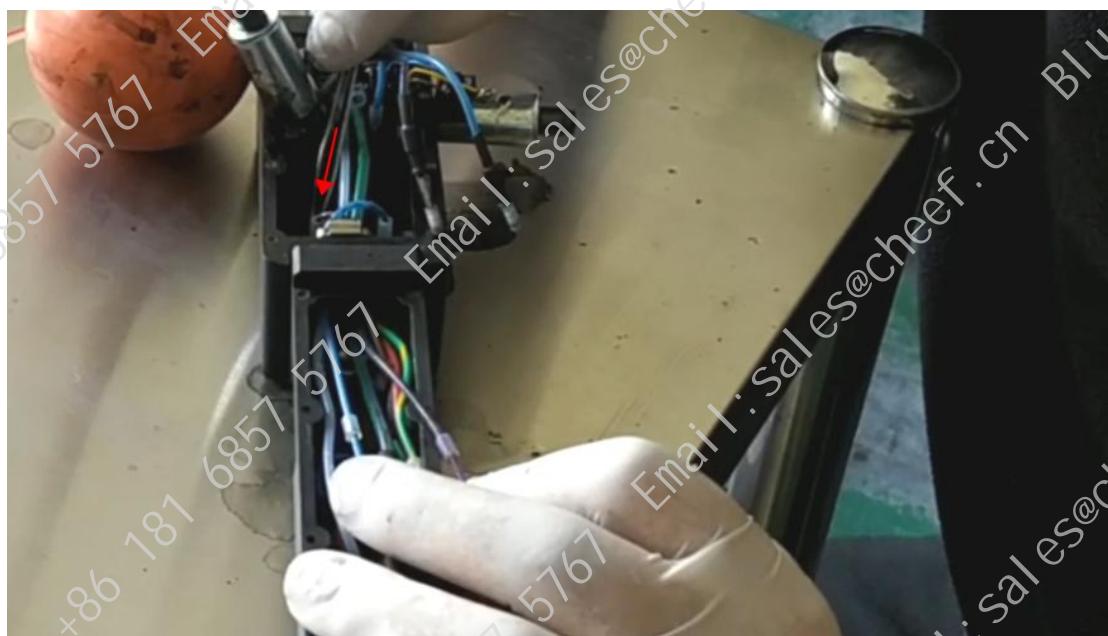
After pulling out, we blow air from one end of the ink supply pipe, and then see if there will be cleaning fluid coming out of the front end of the solenoid valve. If there is, it means that the pipe is unblocked:

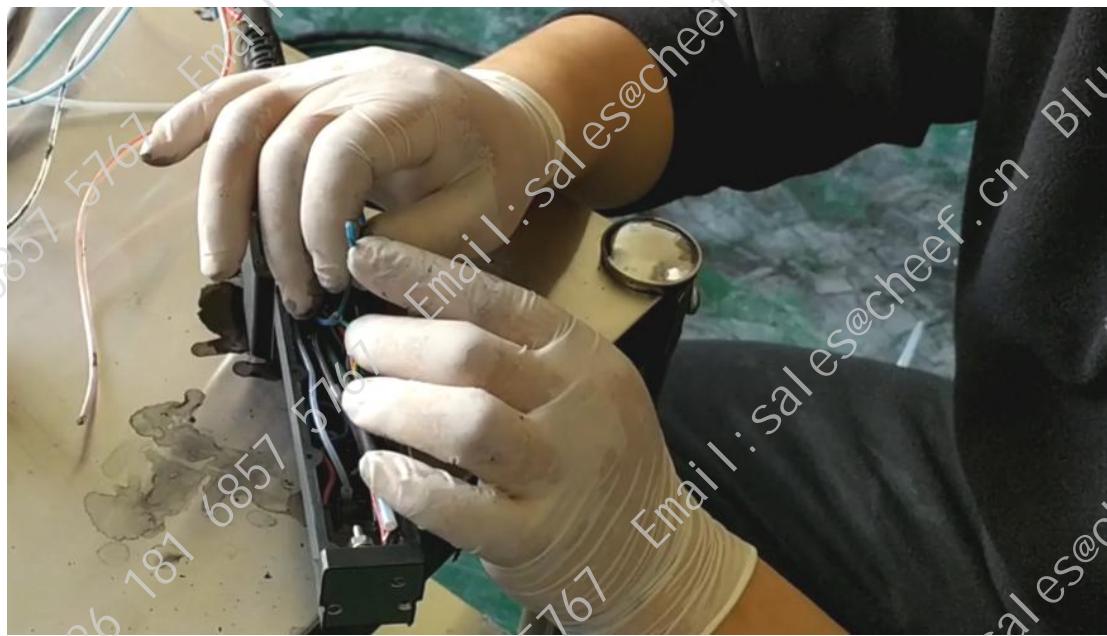
The cleaning tube is not smooth. There is a throttle tube in it. We need to remove it and clean it with ultrasonic wave:

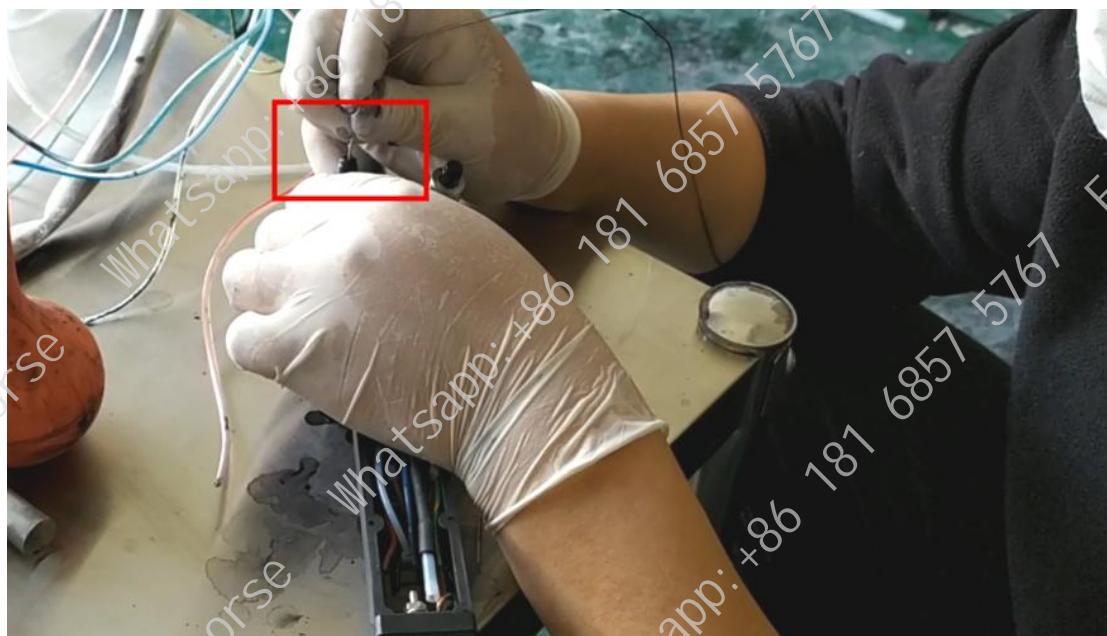
We look at the valve and poke it through the front end of the solenoid valve with steel wire to see if it has spring like elasticity:

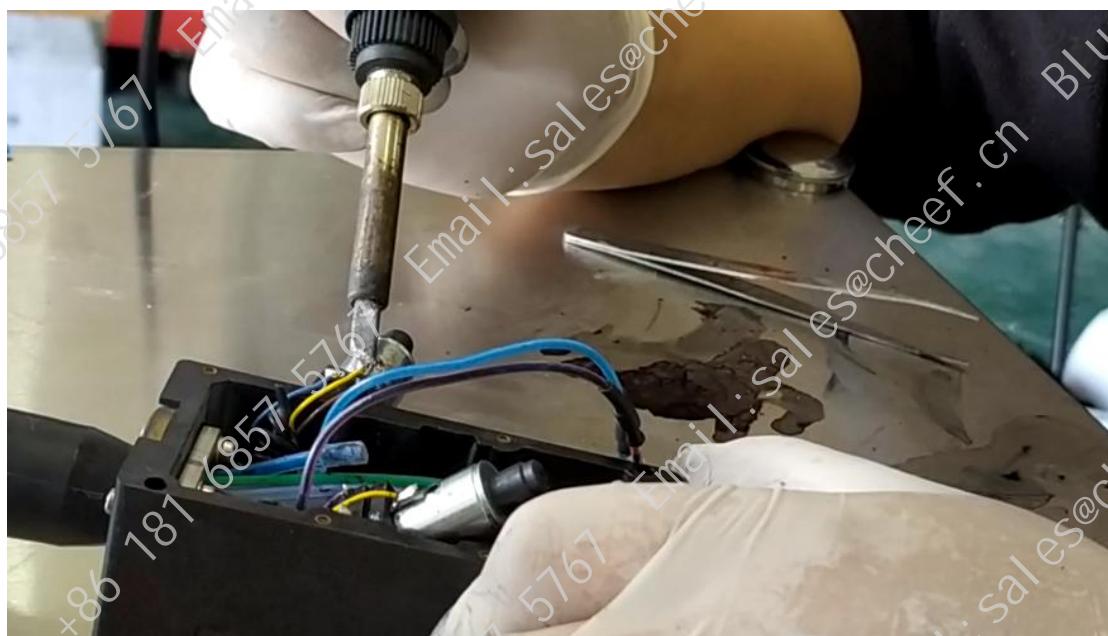
These two valves have no elasticity and are stuck by ink. We remove the blocked solenoid valve. There are three wires behind each solenoid valve. We need to remove it with a soldering iron:

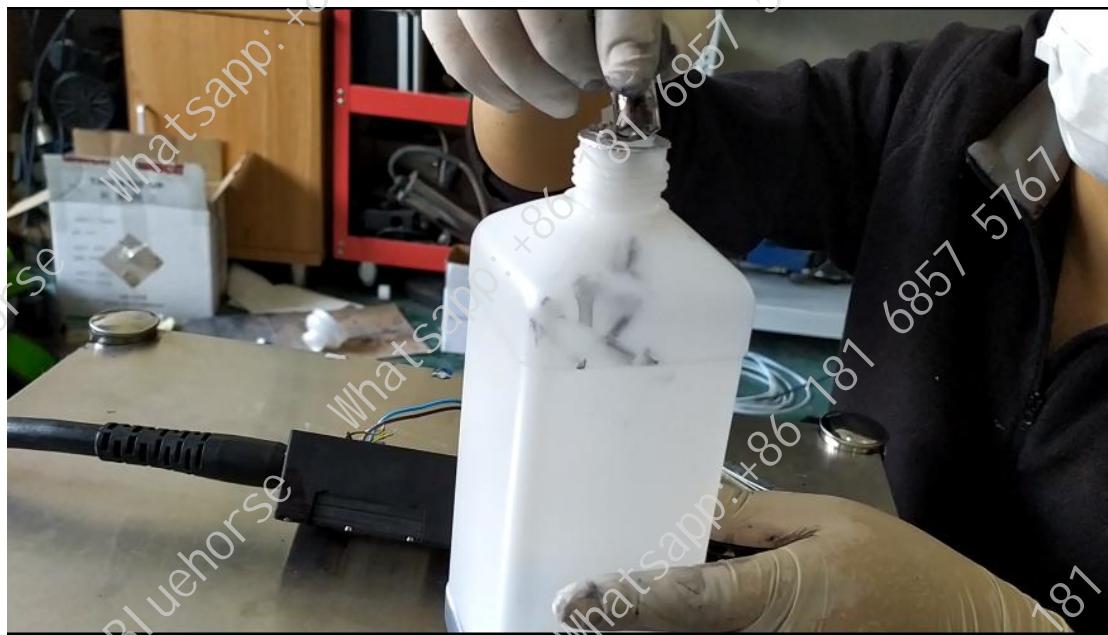
Then put the solenoid valve into a bottle, put some detergent in the bottle, close the lid, shake it, and let it stand for half an hour to one hour. Then we can see if it is unblocked. If it is unblocked, we can install the valve:
