How to handle the recycling failure of Citronix ci1000 inkjet printer?

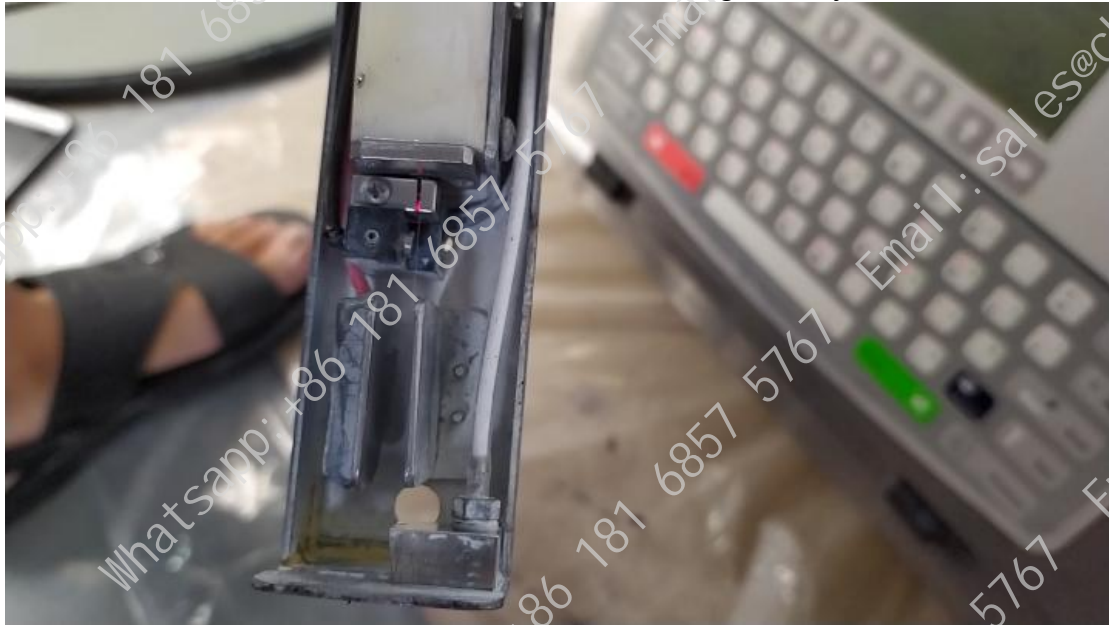
Another is that the ink line deviates and does not spray to the correct position of the recycling tank. That is, when printing normally, the ink line suddenly deviates. If the nozzle has not fallen, the nozzle is generally blocked:

Nozzle blockage, normal, we first wash the nozzle, that is, do not remove the nozzle, and then take the cleaning liquid to the nozzle spray a little cleaning liquid, sprayed after the cleaning liquid, and then normal boot to try.

If the nozzle is still blocked, then we need to remove the nozzle, because Citronix 3200/3300 does not have nozzle cleaning function, so we can only remove the nozzle, and then put the nozzle into the ultrasonic, ultrasonic wave put some cleaning fluid, and then use ultrasonic vibration cleaning, cleaning for hundreds of seconds, cleaning several times in a row, and then test whether the nozzle is clear.

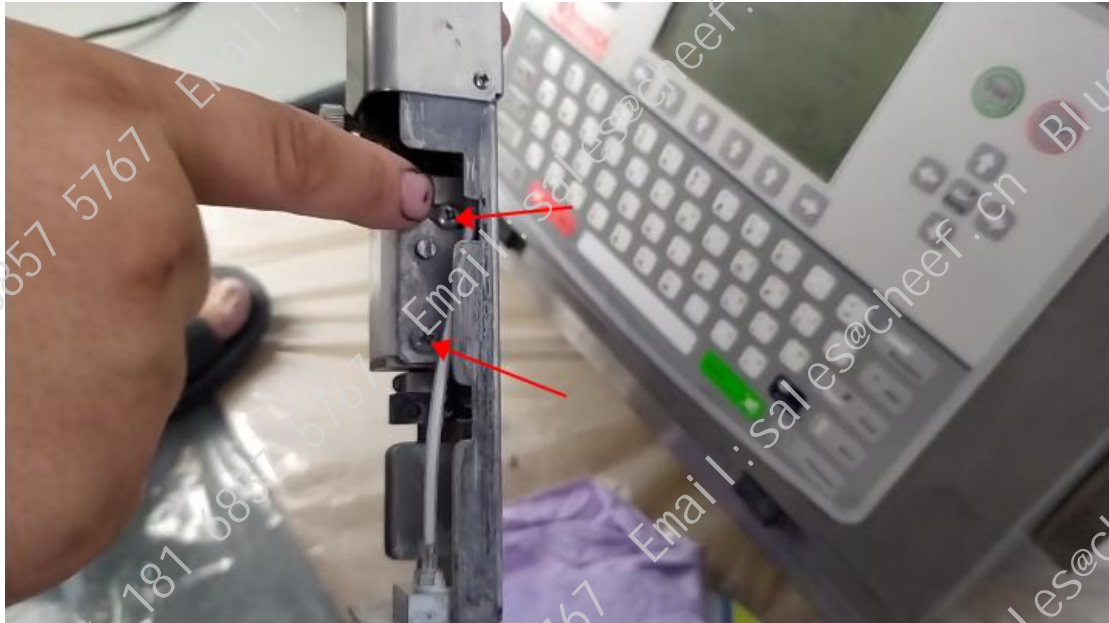
Then if we remove the nozzle, be careful to remove the two screws on the side:

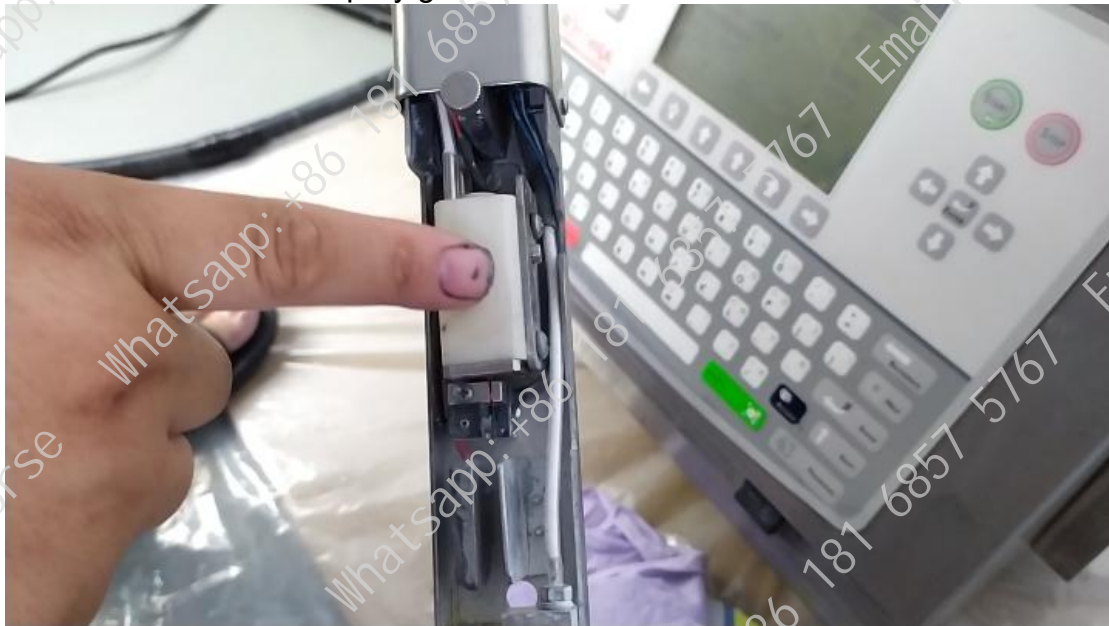
This white module is a spray gun:

Then the spray gun can take it out upward. After taking it out, the two screws of the nozzle can be removed. After removing, the nozzle can be removed. After the nozzle is removed, put the nozzle in the ultrasonic wave, put some cleaning fluid in the ultrasonic wave, and then vibrate, vibrate for five or six hundred seconds. After the vibration, stop for a few minutes, then vibrate again, stop for a few minutes, and then vibrate again. Vibrate several times continuously like this, then we install the nozzle, and then install the screw.

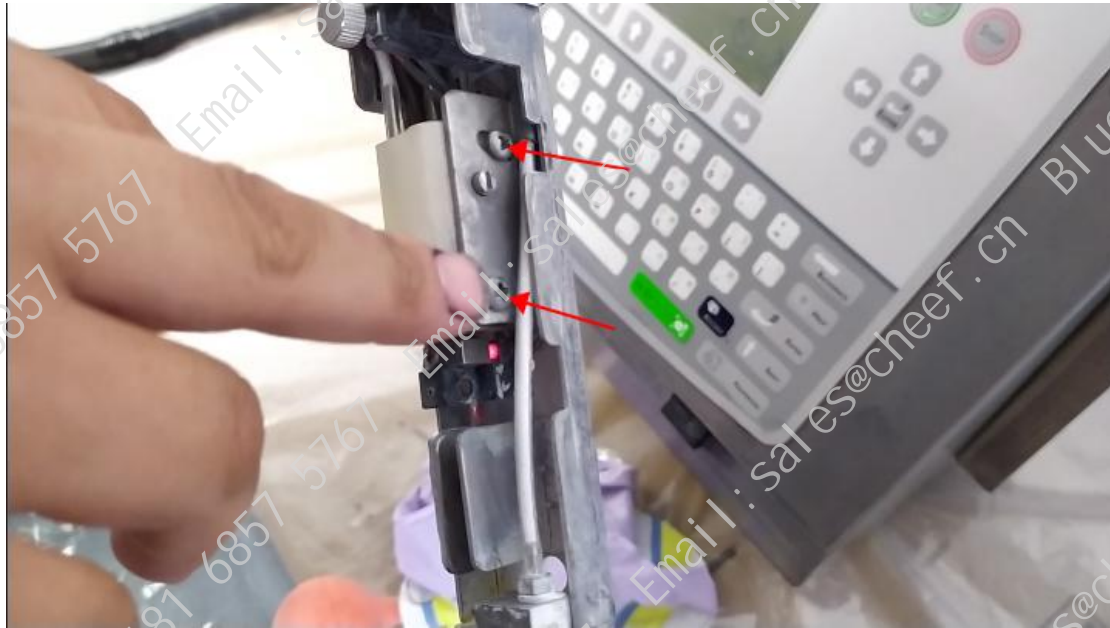
Because the screws here were removed:

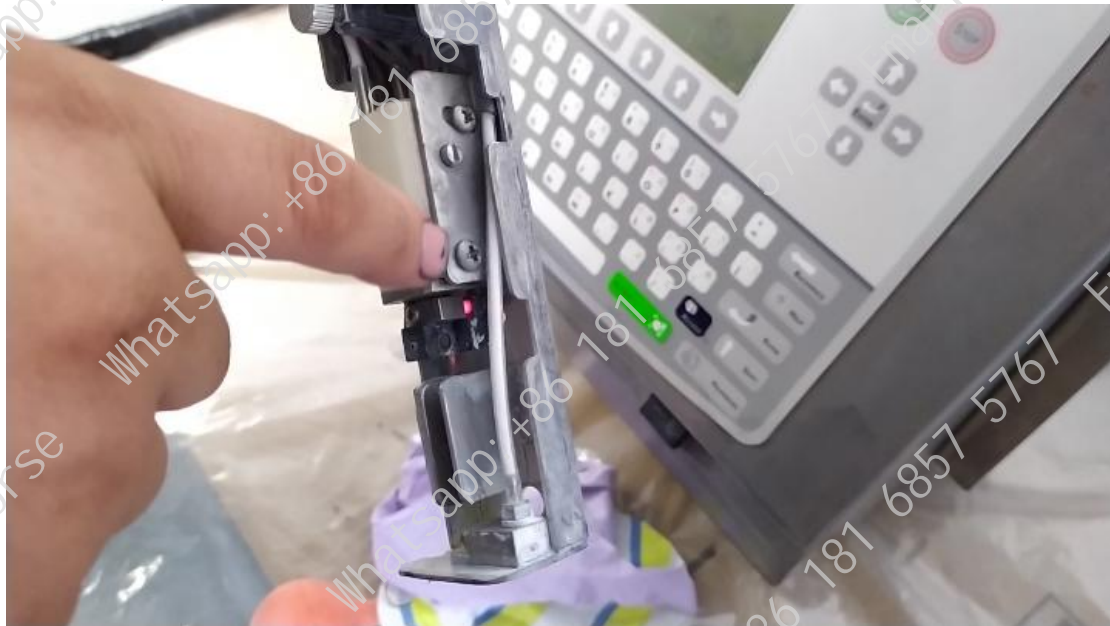
So the ink line position will certainly change, we need to re-adjust, this needs us to know, we first loose this screw:

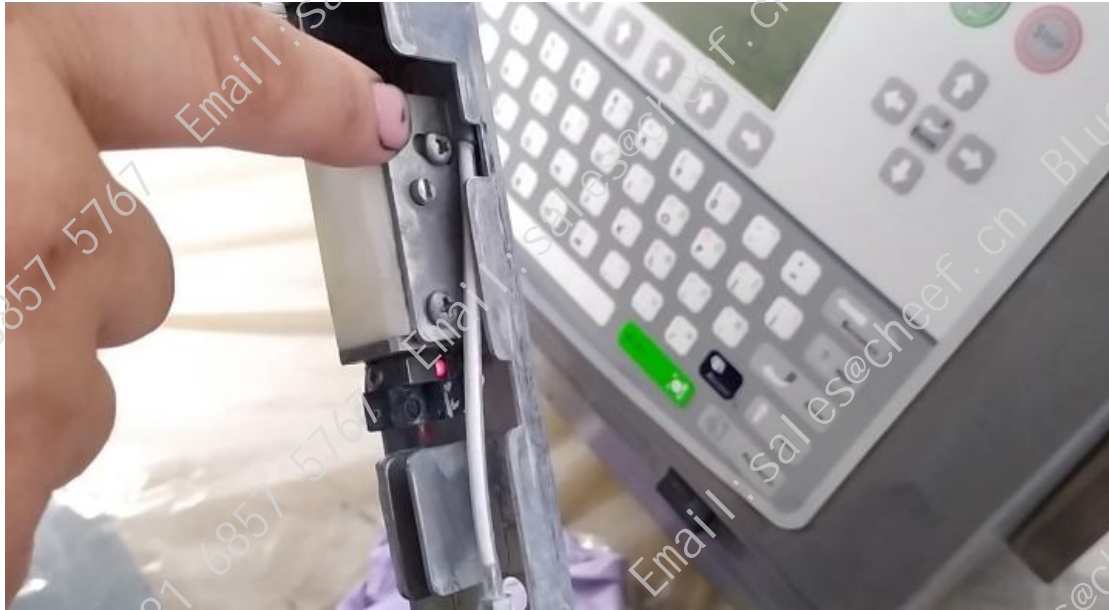
Then adjust the screw, which adjusts the front and rear of the ink line:

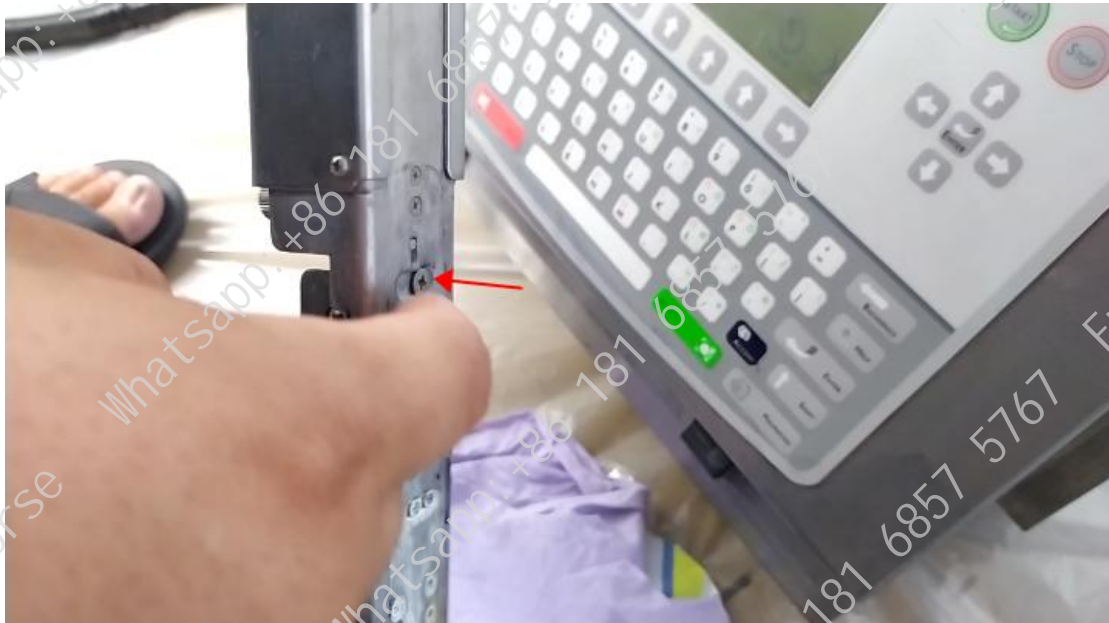
Then we loosen the screw:

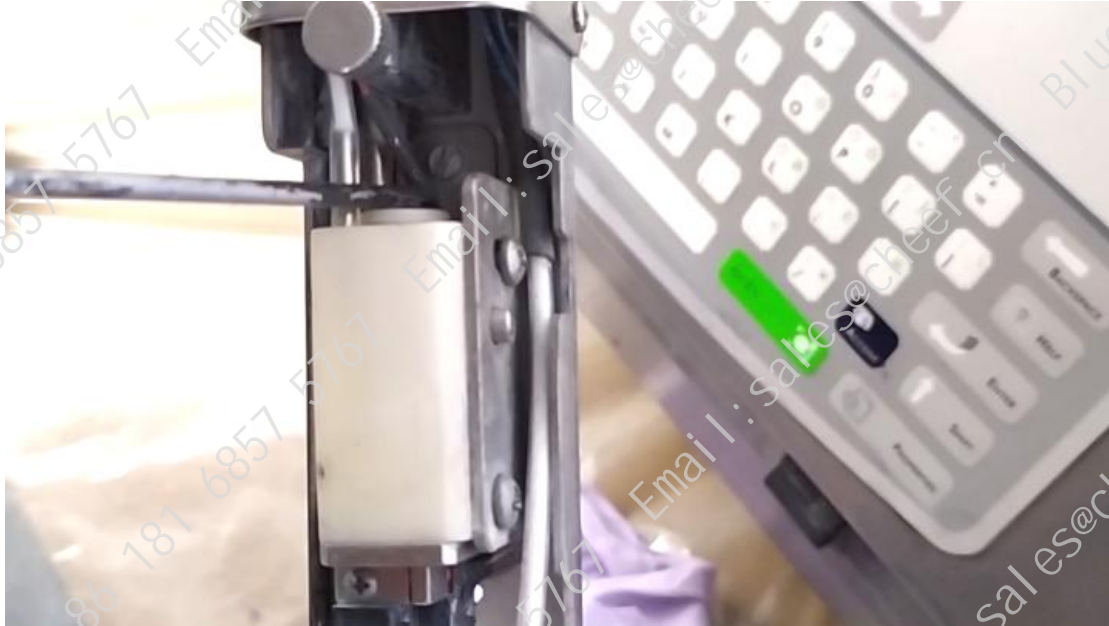
Then adjust the screw below, adjust this one-word screw, can be used to adjust it around, spin it can adjust the ink line to the left and right, so that we will adjust it to the correct position of the recycling tank:

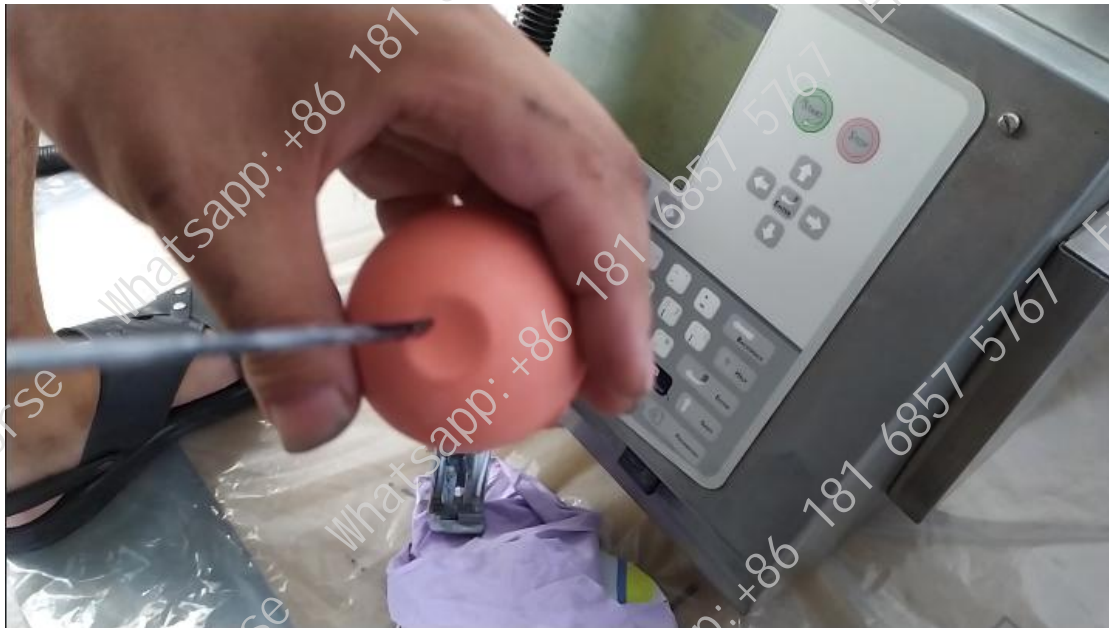
If this circle is a recycling tank, the ink line position should be at this location:

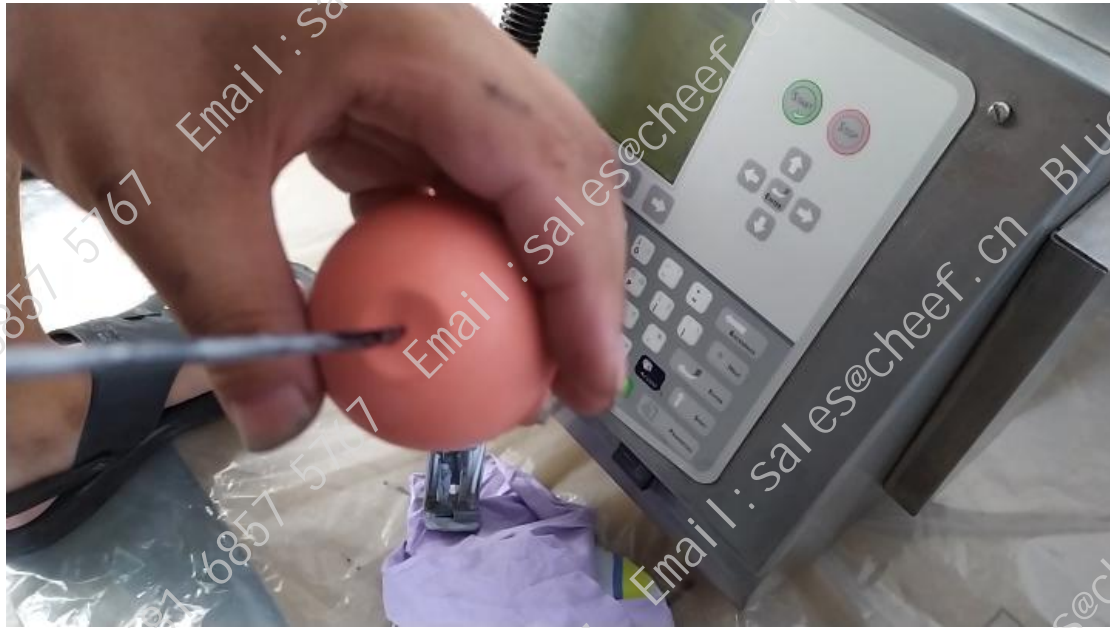
Ink lines can't be in the middle like this:

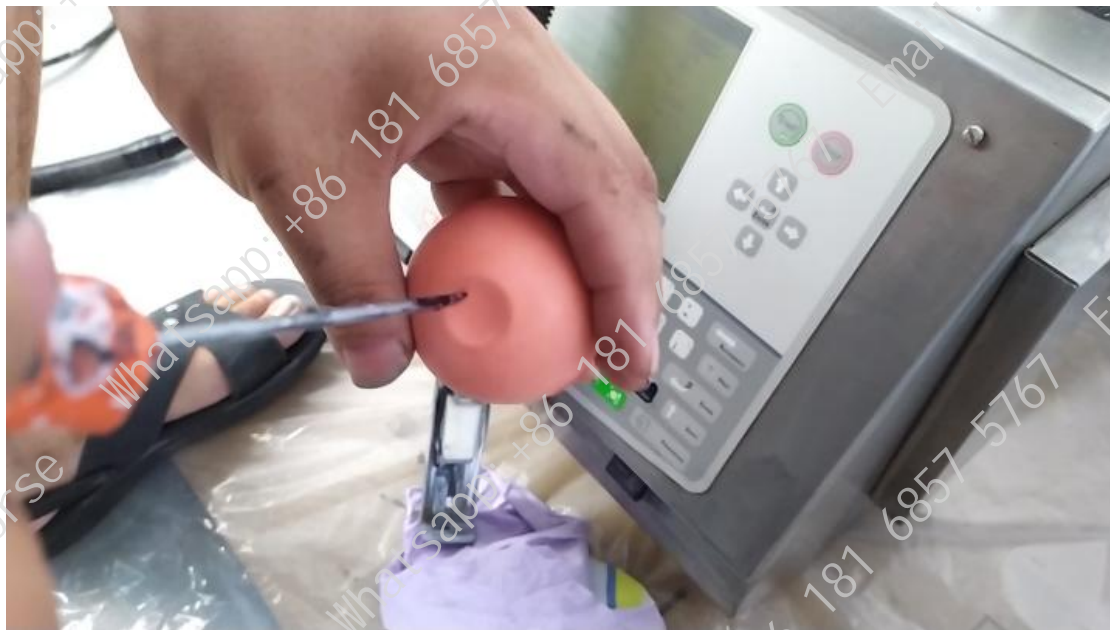
And then we look at it this way, it's left-leaning:

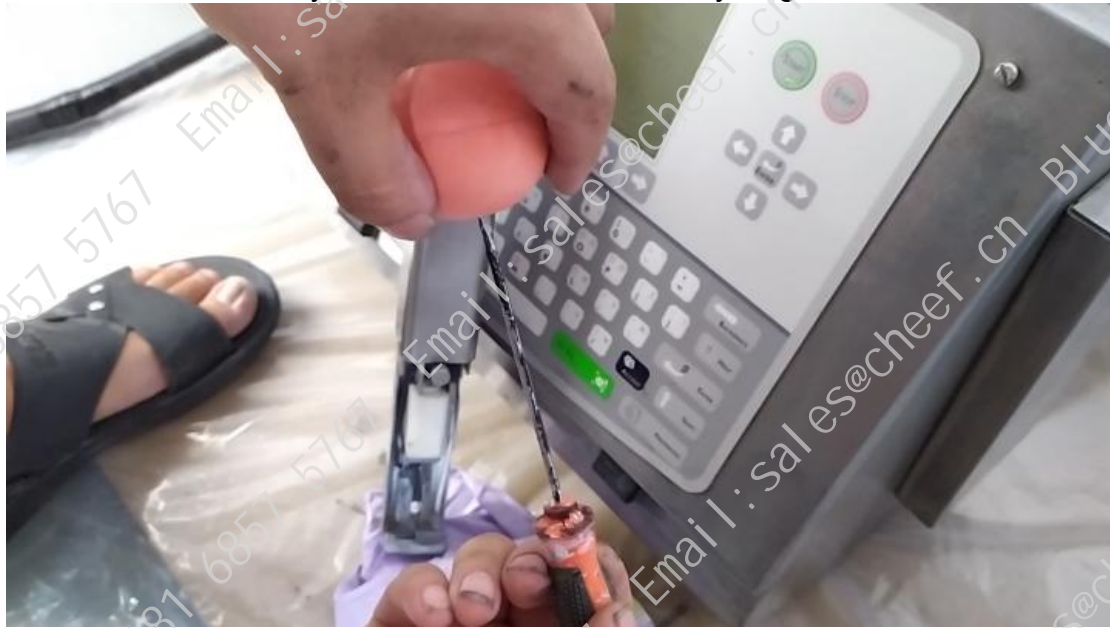
If we look at it this way, it's in the middle of the recycling bin:

Then we adjust it, then we can run, and then run for a while to see if it is stable, if stable, it means that we have adjusted, this is nozzle blockage, ink line bias, that is, our common recycling failure.
