How to disassemble the ink core of Imaje 9020 inkjet printer?

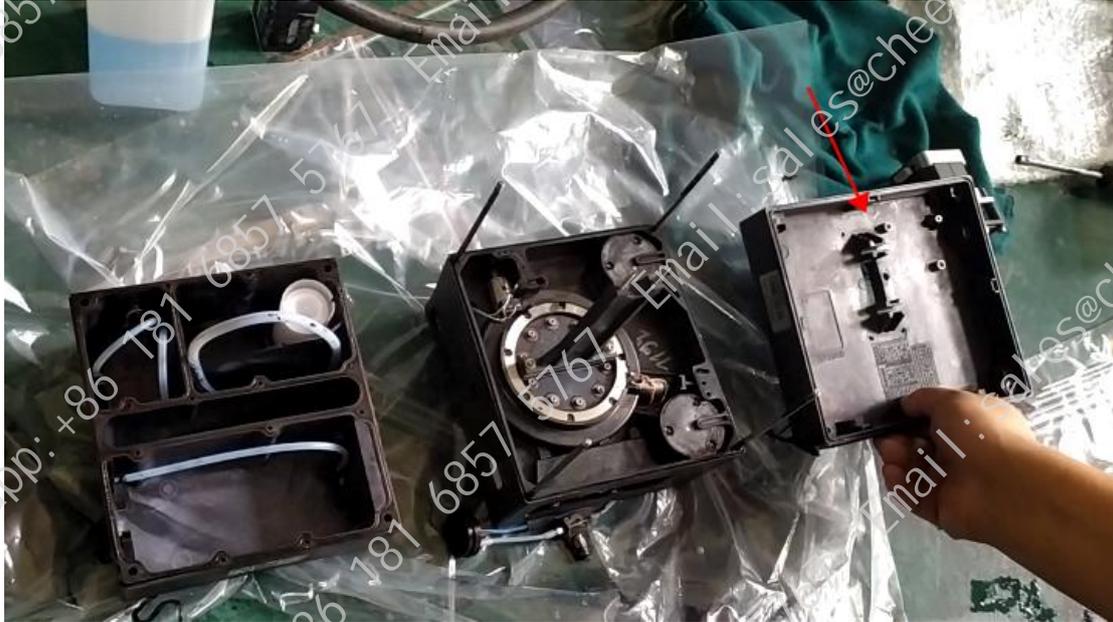
Now that it's all been taken apart by me, the 9020 ink core can be divided into three pieces. This is the lid:

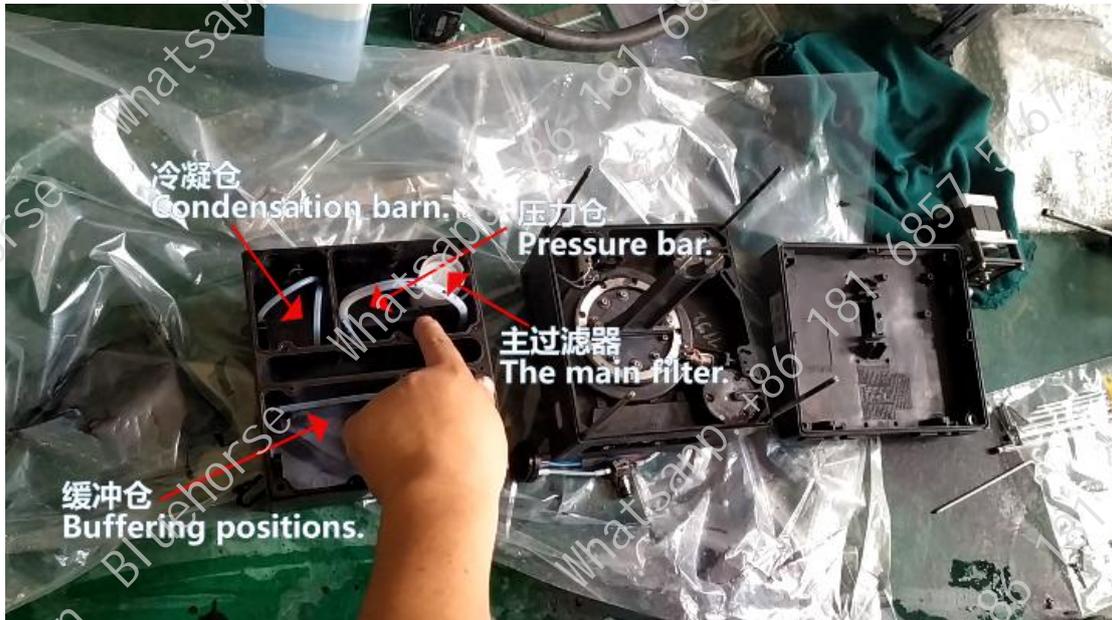
This is the middle, divided into three chambers:

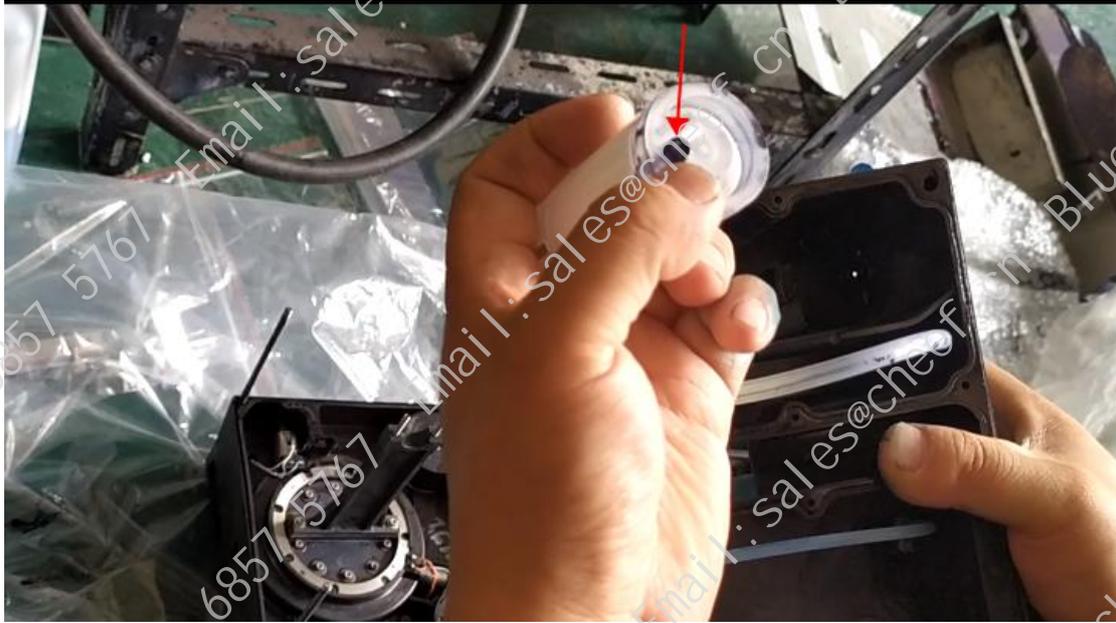
There is a main filter in the pressure chamber, the main filter replacement is also very easy, we gently pull it out, and then, we just point this hole at the pressure warehouse main filter hole down, we can install it:

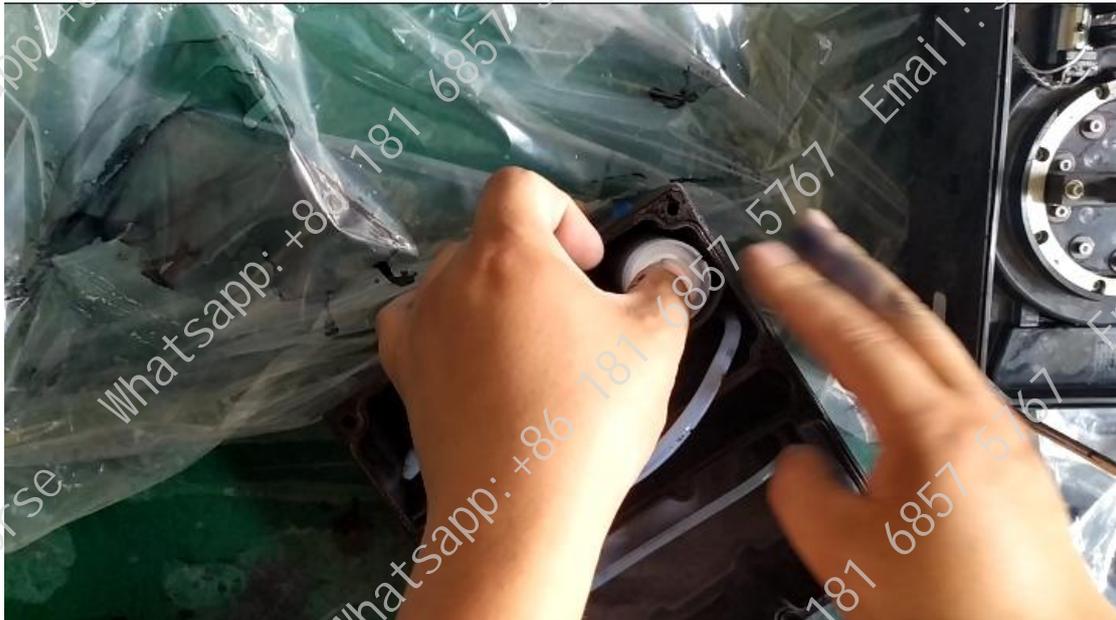
Press it tight until it cannot be swirled to the left and right, and the main filter is installed:

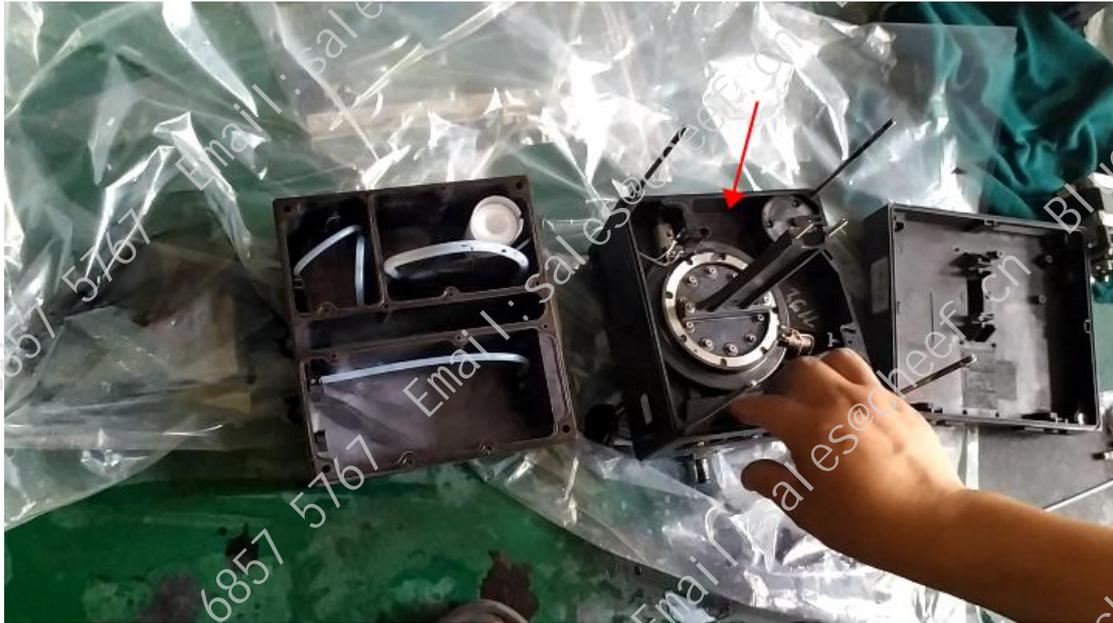
The main thing is the lower half of it, solenoid valve, ink core plate are here:

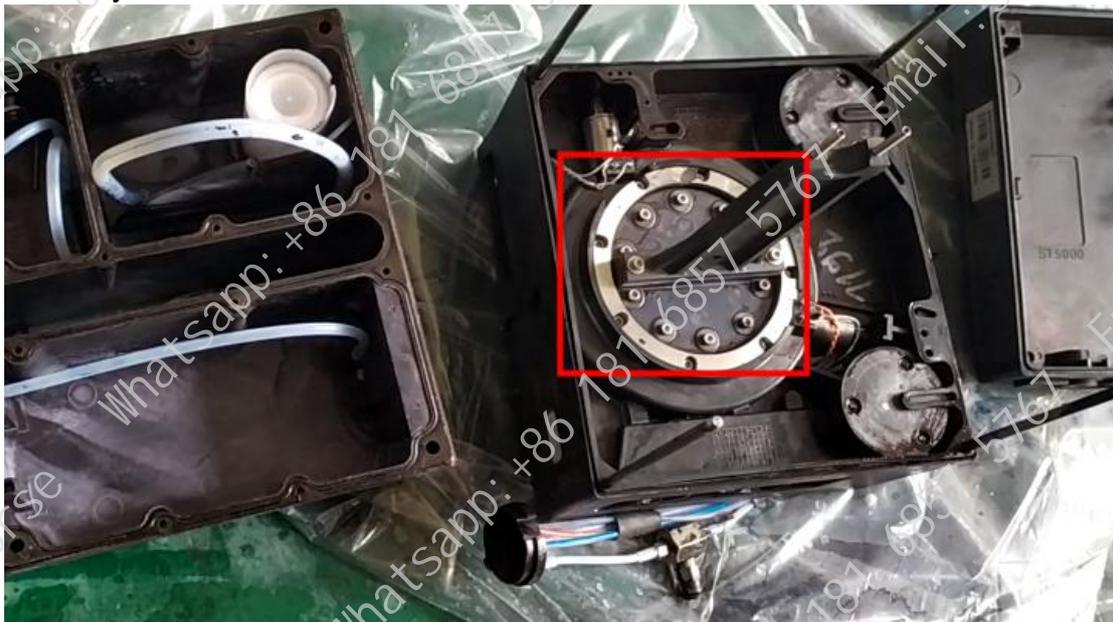
Here are a few screws, two diaphragms under the screws, one pressure and one recycled:

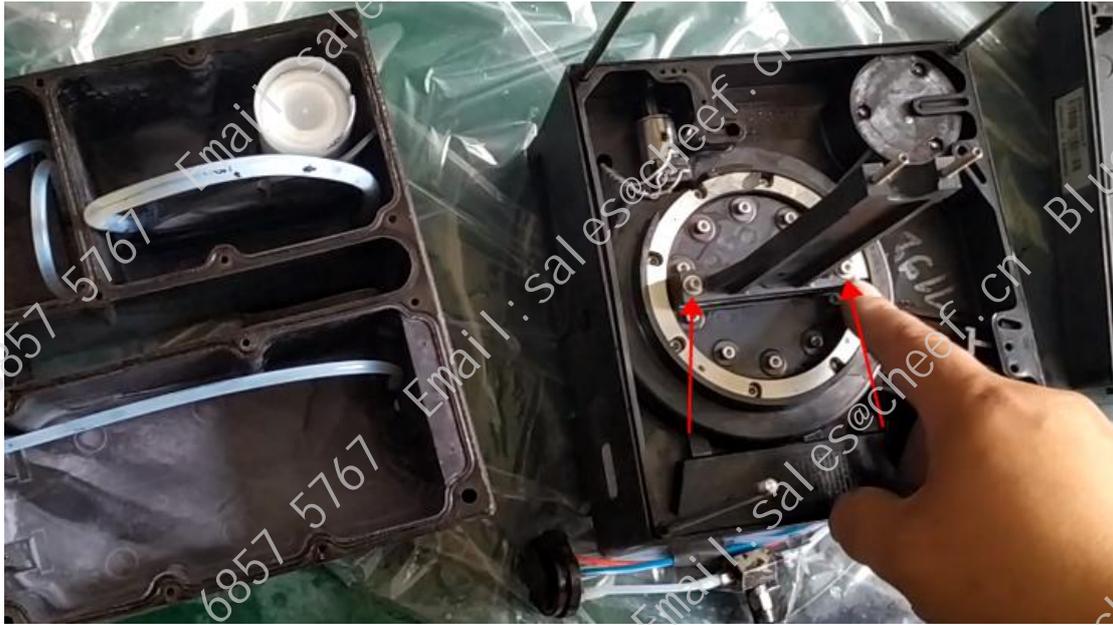
If you want to replace the diaphragm, do not move the two screws because it rotates:

Then take all these screws around, pay attention to, screw size, length is not the same, do not mix placed together, if mixed, easy to install not tight, easy to leak, resulting in ink leakage.

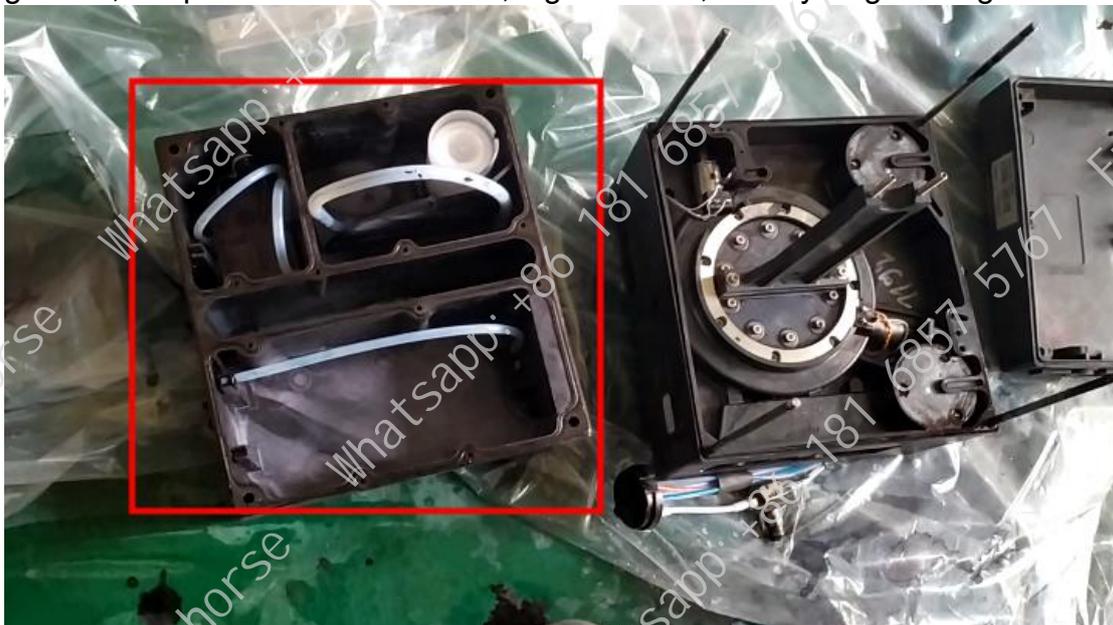
Originally only the middle layer is ink, unless the diaphragm is broken, in general, the pressure is not correct, high and low, or recycling is not good:

Generally speaking, if the test is that the solenoid valve is good but not well recycled, it may be that the recovered diaphragm is broken, which requires us to replace the diaphragm inside.

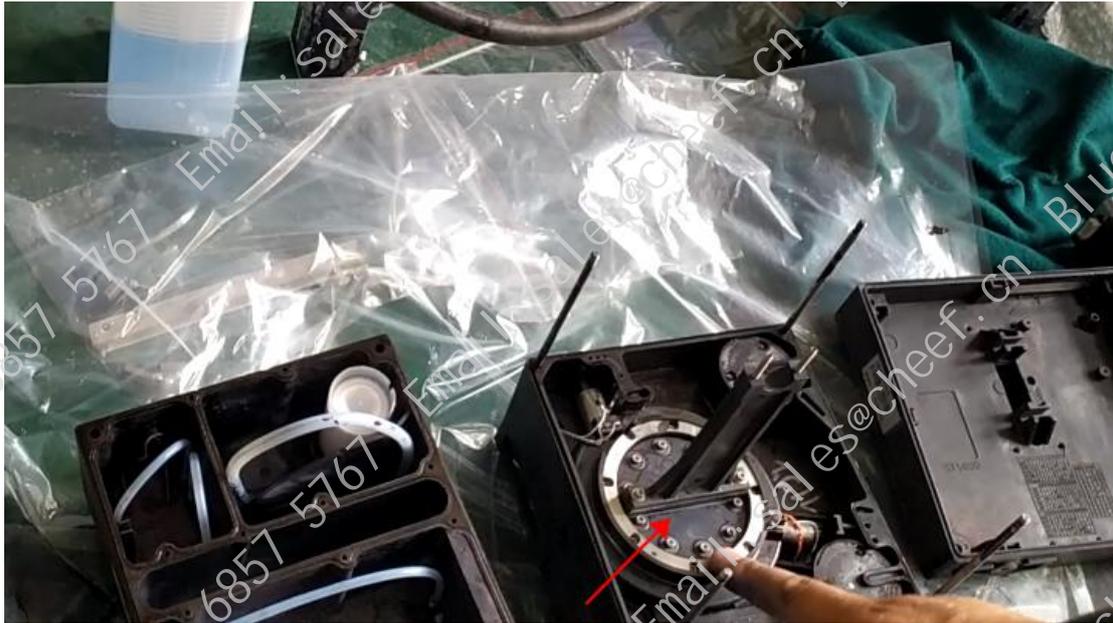
The uppermost diaphragm is recycled, and the lowermost small diaphragm is stressed, with compartments in the middle and two not attached together:

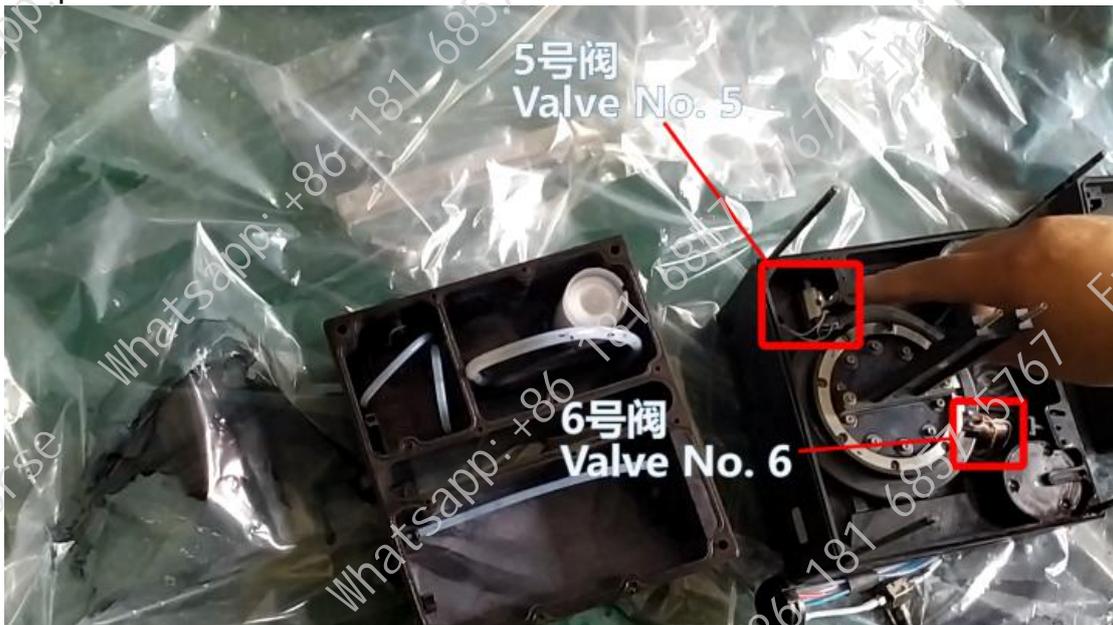
These two are solenoid valves, Valve 5, Valve 6, both of which play a role in recycling. If the recovery is not smooth or the valve does not ring, the test is the problem of valve 5 or valve 6:

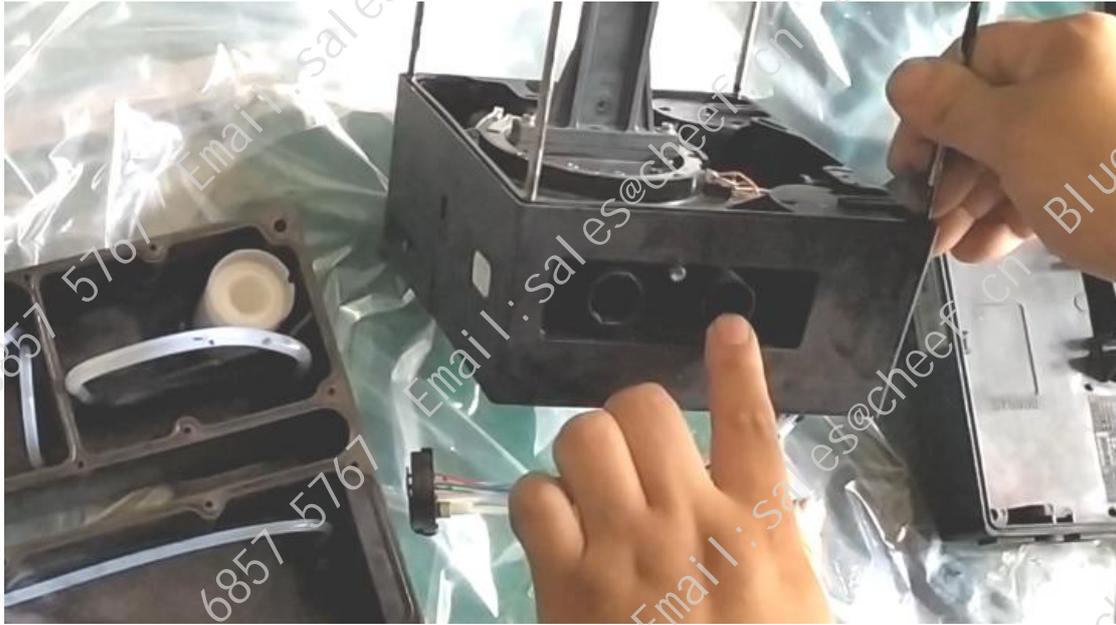
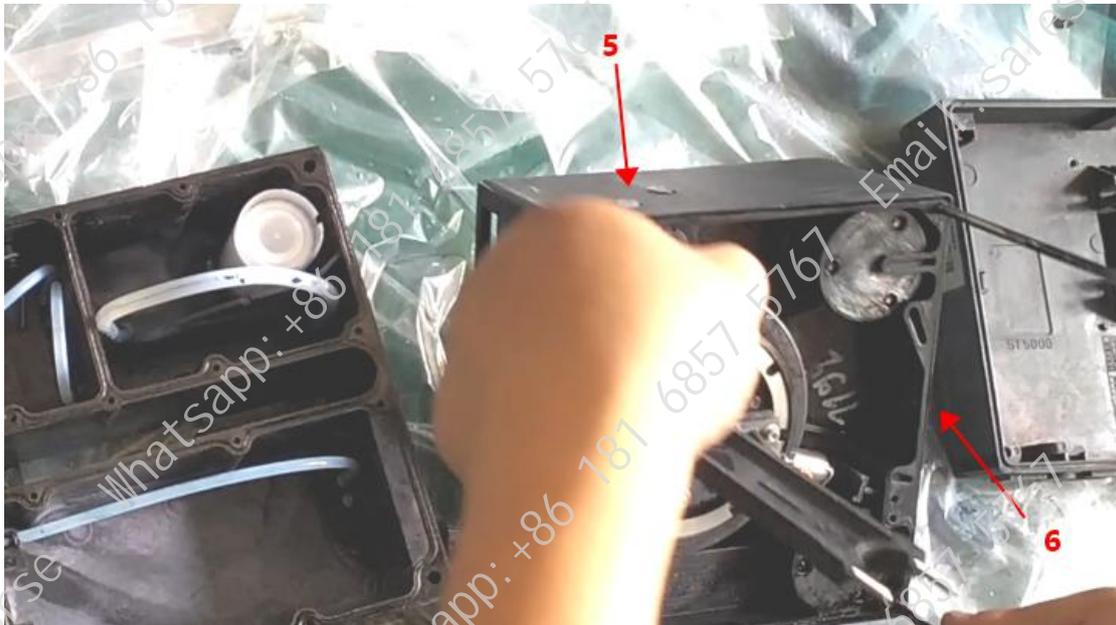
In the ink and solvent socket facing our own premise, the back is valve 5, the right side is valve 6:

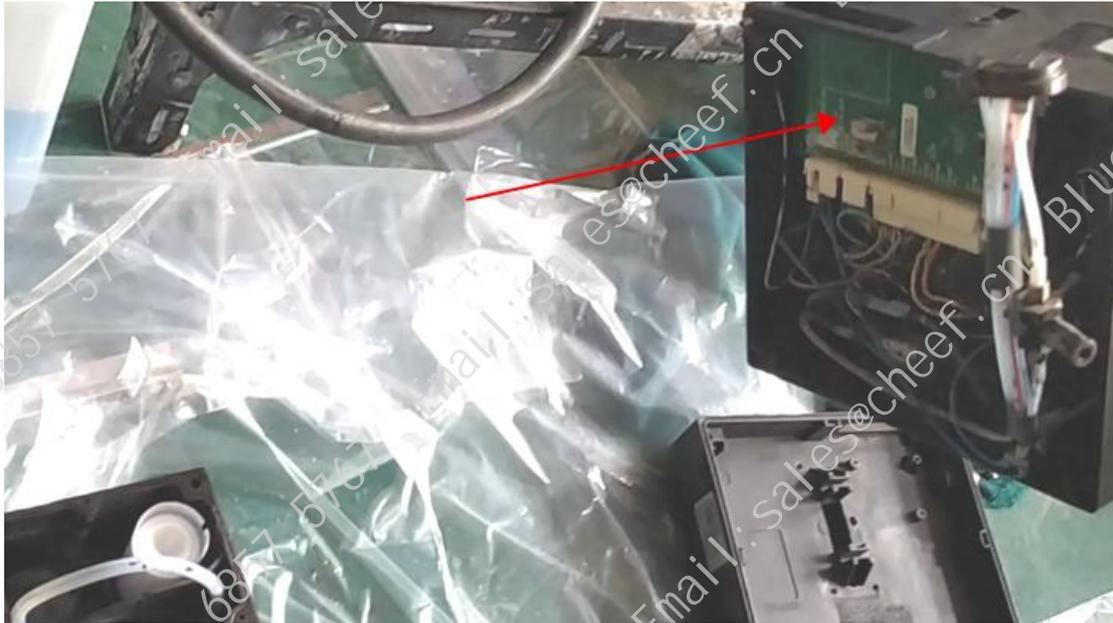
If the valve 5 or 6 is to be replaced, the ink core must be removed. If you replace another valve, remove the ink core plate directly from the bottom, take down the above several screws, the valve will be exposed:

These screws on the ink core are not the same, to be placed well. The first time to disassemble, be sure to note the screw position, screws have a lot, place the position do not confuse.

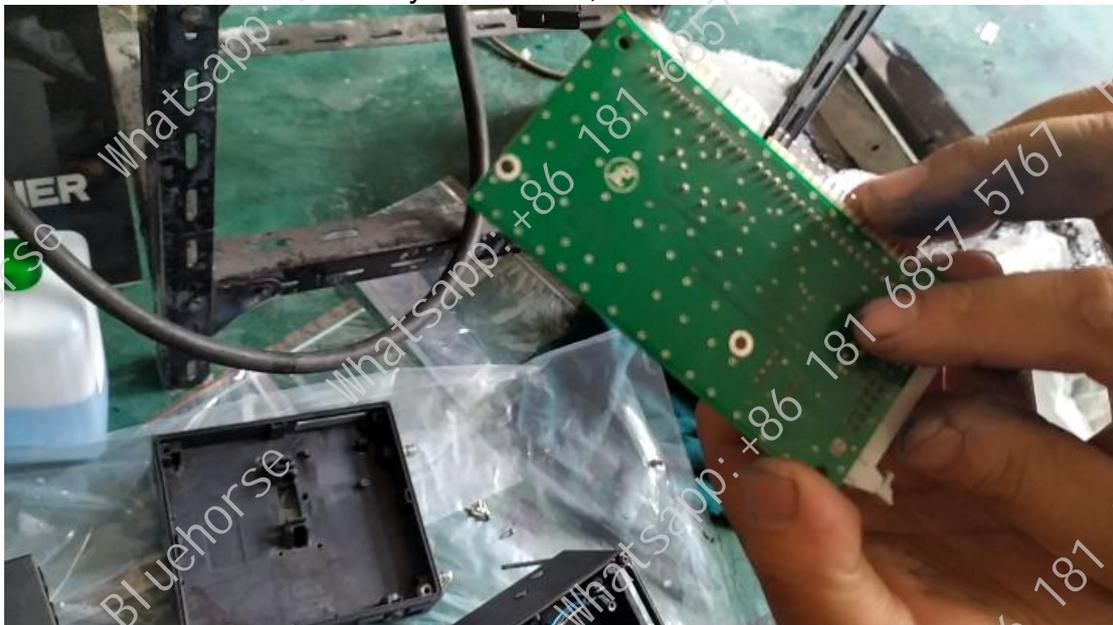
Remove the screws on the ink core plate, pull lines off, and the ink core plate can be removed. Removed ink core plate, whether it is the front or back, as long as there is ink or dirty, to wash it clean with cleaning liquid, wash it clean, with the cold air of the hairdryer to blow it, be sure to use cold air:

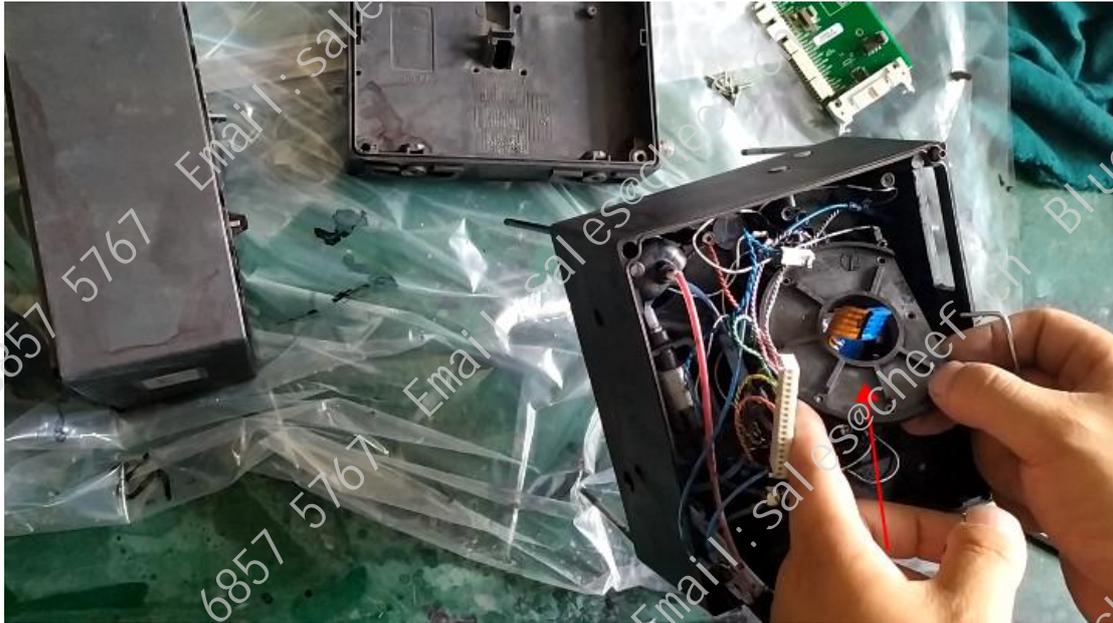
Since both the solenoid valves and the pressure sensor are underneath, remove the cover:

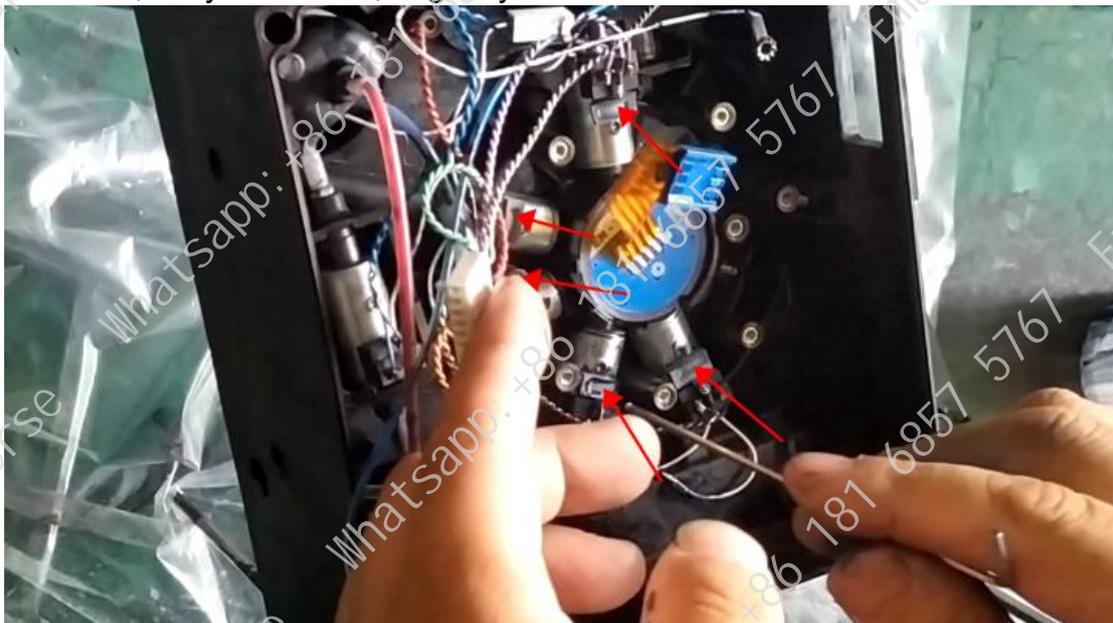
There are 5 solenoid valves under the lid, be careful when removing them, and each valve has a pressure bar on top of it. The pressure bar must not be removed, if the pressure bar off, because the ink core is facing down, it is easy to loosen, easy to leak ink, to gently:

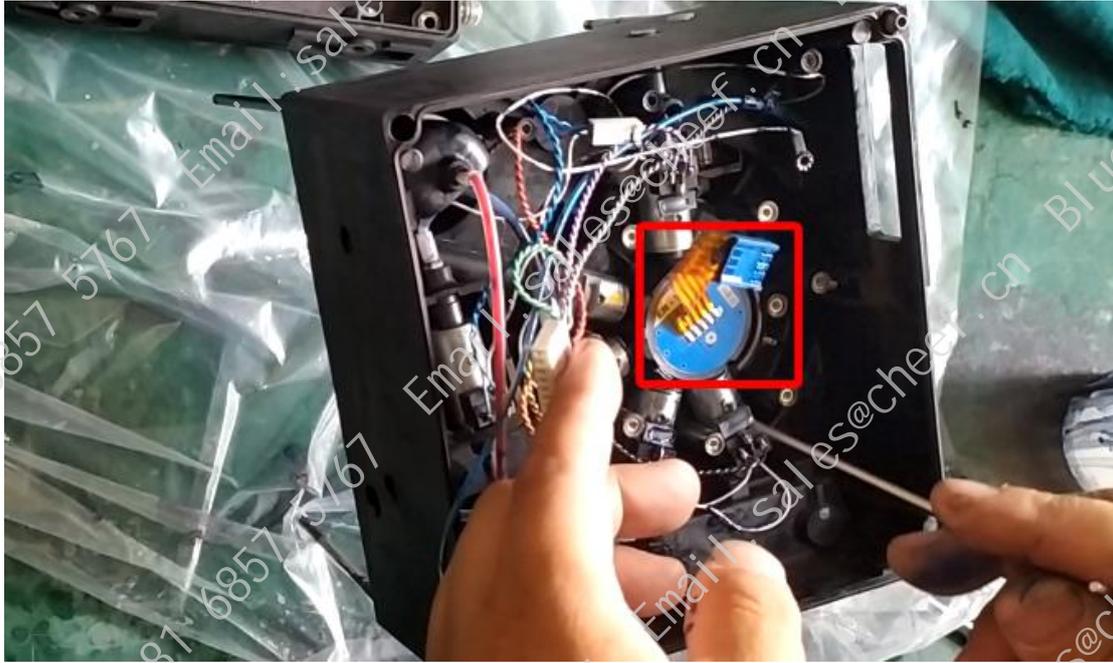
This is the pressure sensor, there is an O-ring below. All pressure sensors have an O-ring:

If the pressure is not correct, it may be the pressure sensor, but because the pressure sensor is connected to the ink core plate, it is also possible that there is a problem with the ink core plate.

From simple to difficult, first determine whether it is a pressure sensor problem, then see if it is a problem of ink core plate, and finally consider the problem of motherboard.

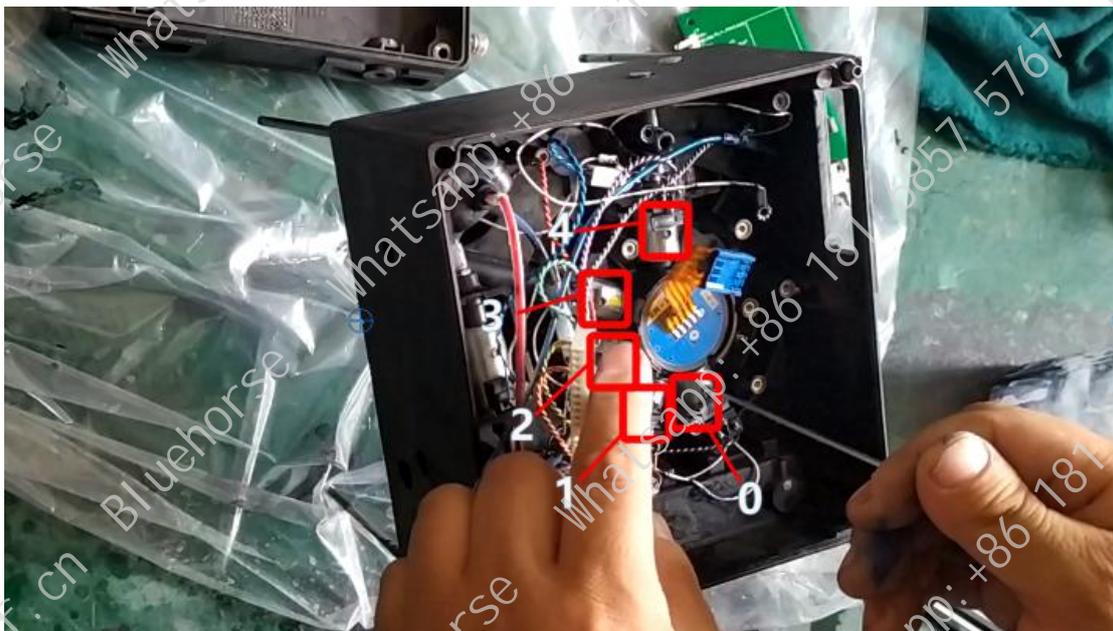
This is the solenoid valve, which valve is broken to replace which valve on it:

When the machine is tested, if it rings, the valve is not necessarily good, but it does not ring, it is necessary to consider what the problem is. We can change the valve, or open this valve, and then use the meter to measure the voltage is not 24V, there is no voltage down, if there is no voltage down, from the line to the plate of this piece is certainly a problem. If there is voltage down, but the valve does not ring, it is the problem of the valve, either blocked or damaged.

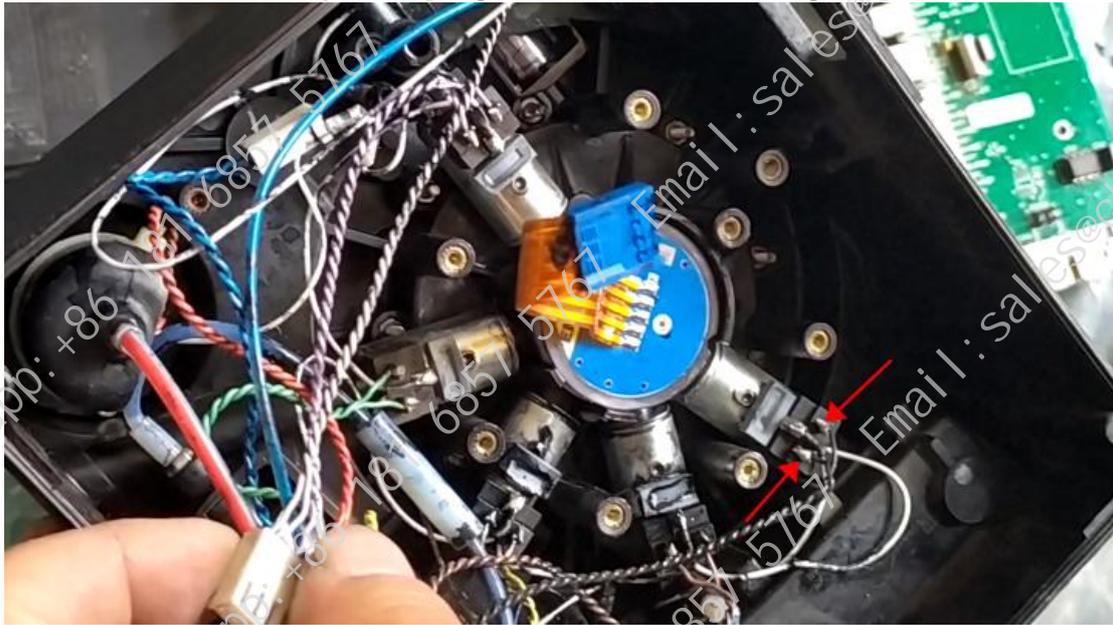
If the volume of voltage, each solenoid valve has three lines, the above line is the ground line, we only need to measure the voltage of the left and right line, DC 24V, the valve is open state, give it current and voltage to measure:

When replacing the valve, if you are afraid of wire welding confusion, for example, it has the same two brown lines, but the positive and negative poles can not be reversed. So if we determine that it is a valve problem, we take a new valve, we weld off a line, we weld it to the new valve, and so on, the new valve on the three lines after the replacement, the old pry down and then install the new valve. Then the test doesn't ring, and if it does, it's OK. Remember that the pressure bar above the valve must have, otherwise the time will be long will leak ink.
