IMAJE 9040 Inkjet Printer Repair Guide - How to adjust the ink line?

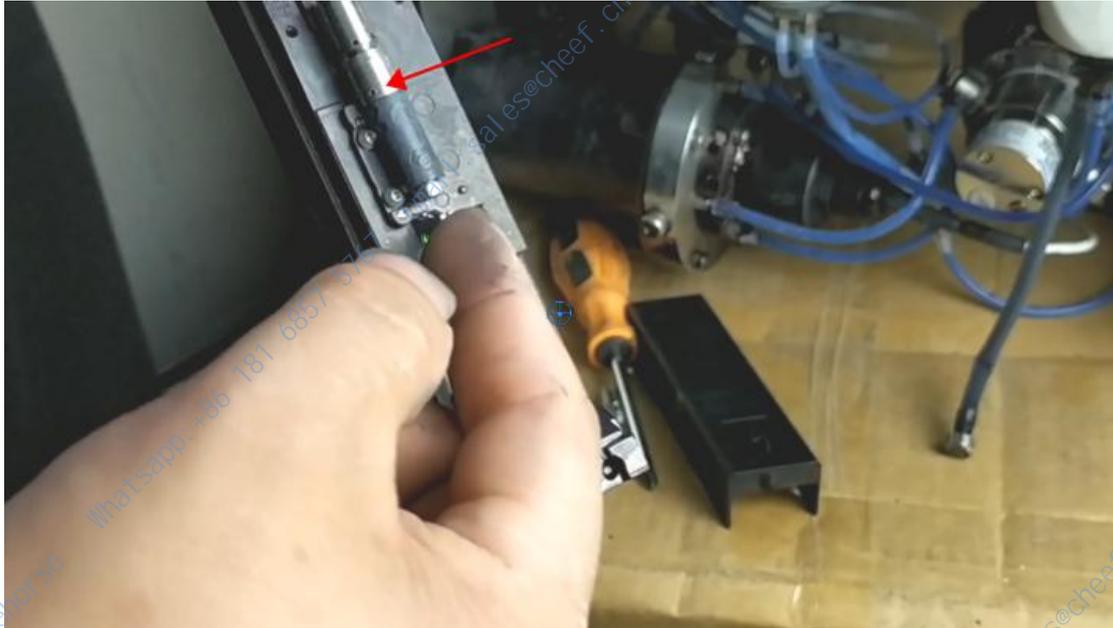
If the ink line is a little bit off, we'll spin this, and then the nozzle can be adjusted left and right:

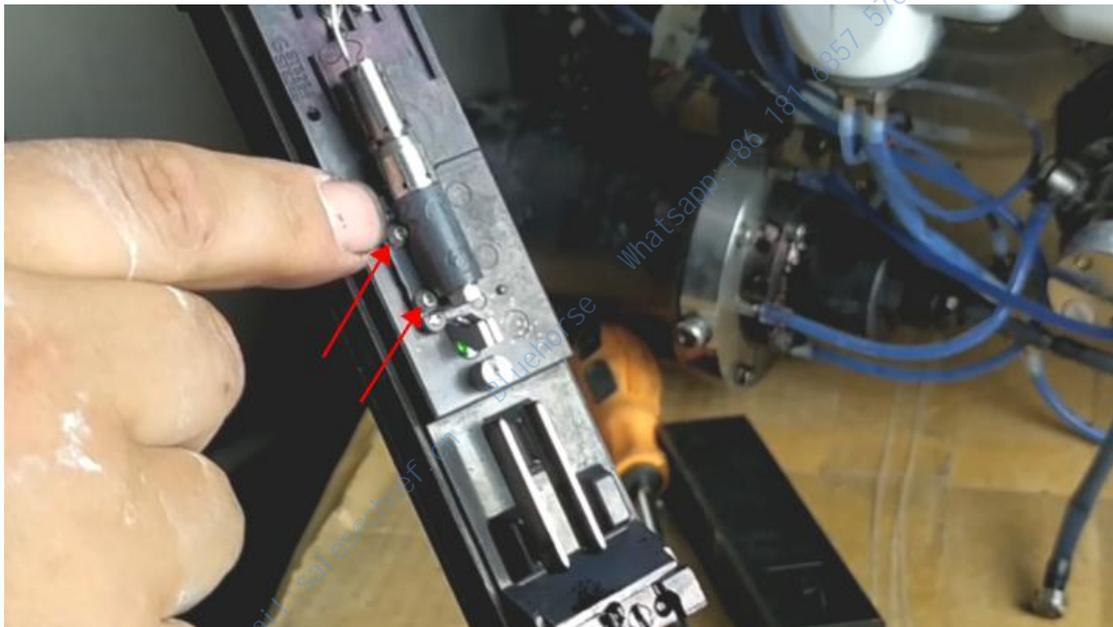
If the ink wire deviation is very large, let's loosen this screw a little bit with this screw:

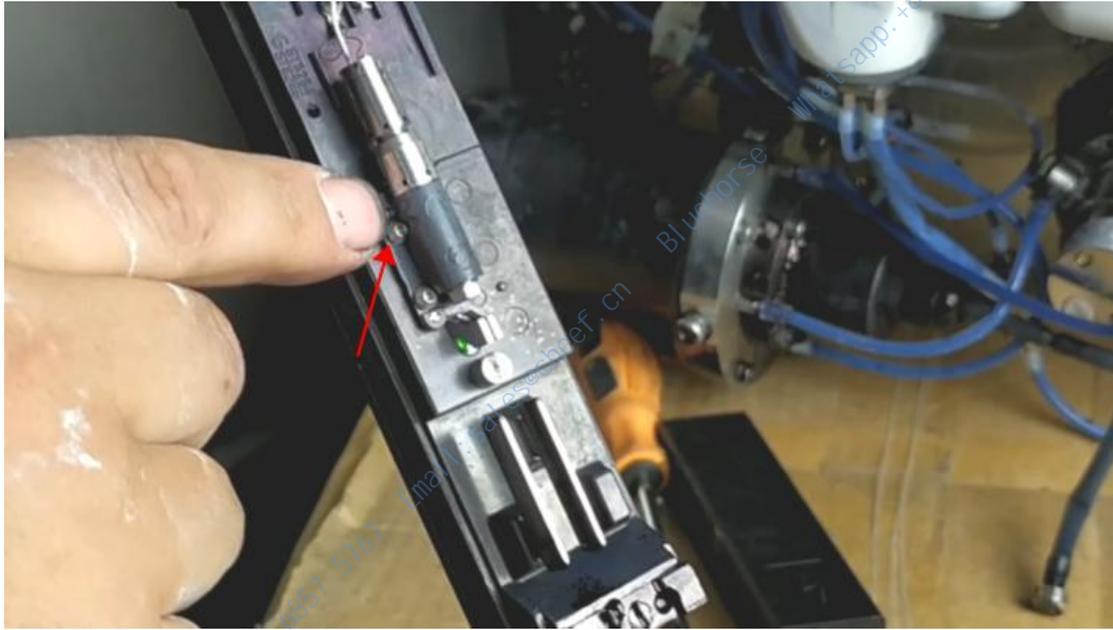
Then adjust the screw:

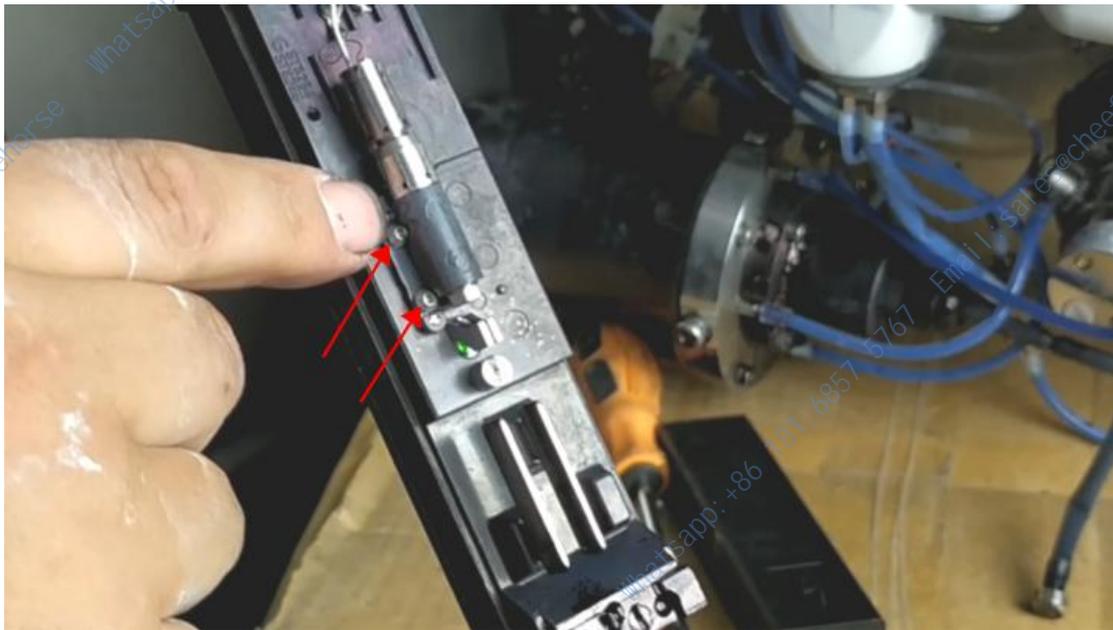
If the ink line is not very large, the two screws do not move:

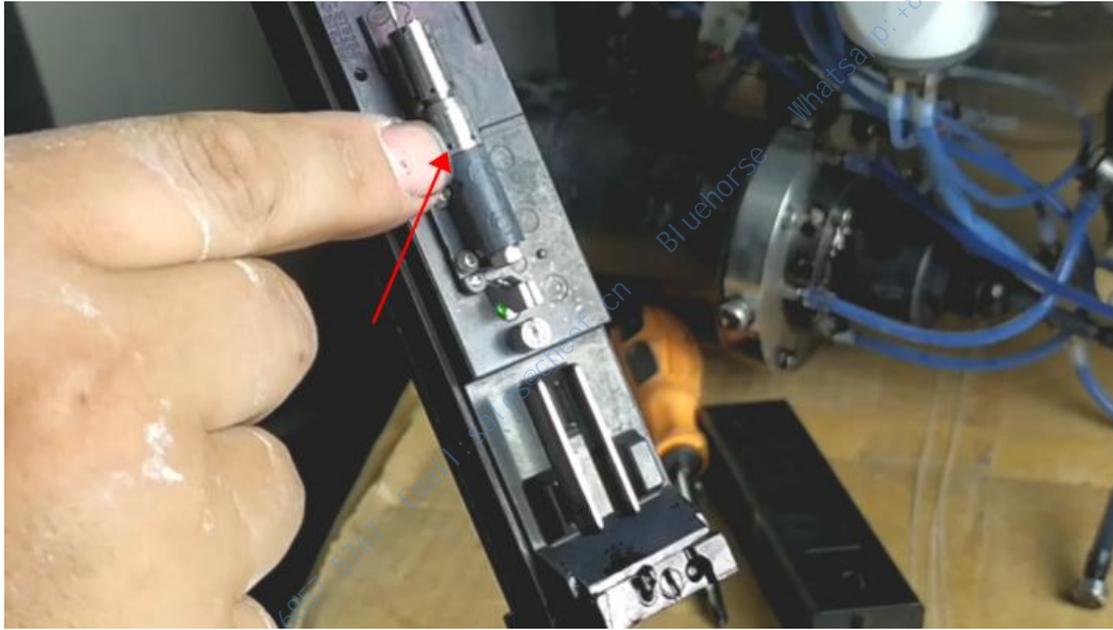
Just spin this, turn left or right, it can also adjust up and down and left and right:

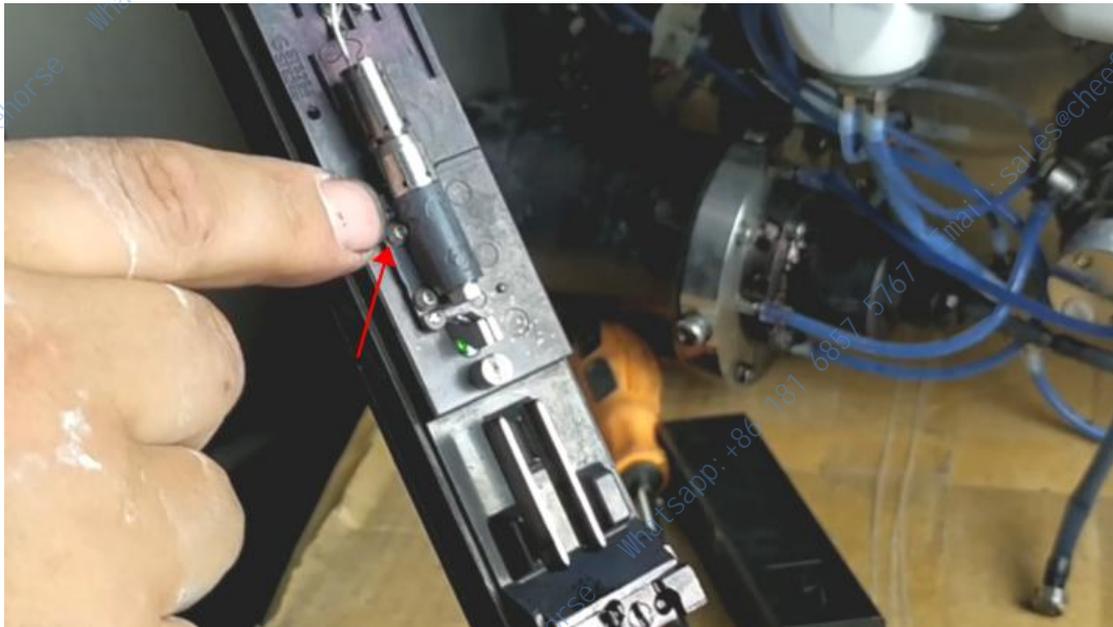
But if the deviation is outrageous, or if the fixing sleeve has been removed and reinstalled, then we must first identify this one, and first make a big adjustment:

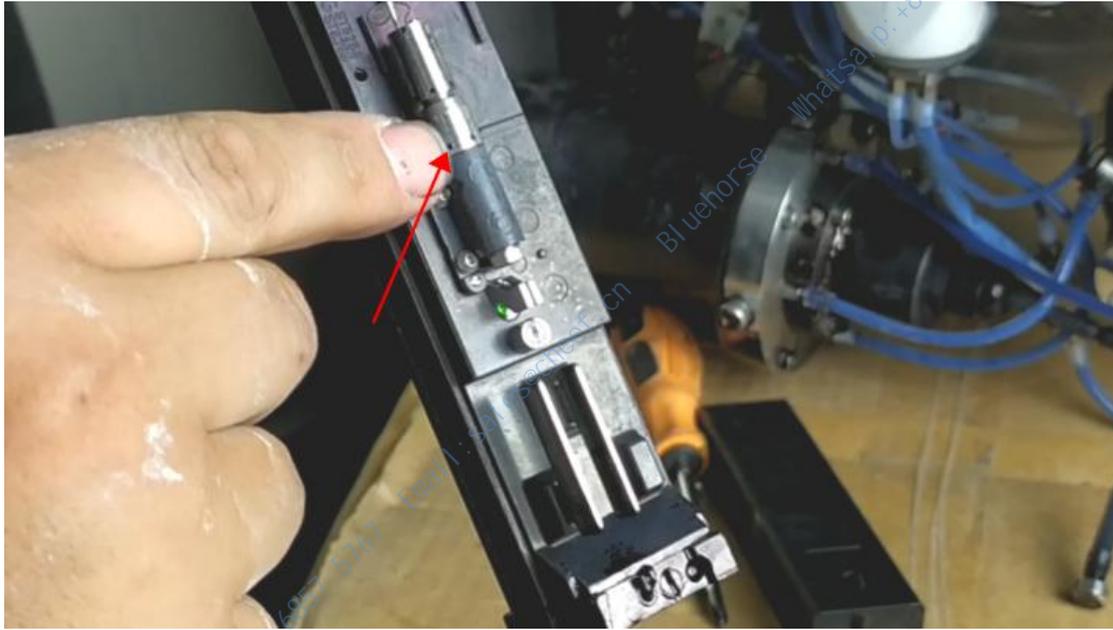
Then tune this and fine-tune it:

If these two places have been adjusted, but they are still not adjusted well, or there are still some deviations, we will adjust the recovery pipe, but only if the nozzle is unblocked, that is to say, the ink line deviation is not caused by nozzle blockage.

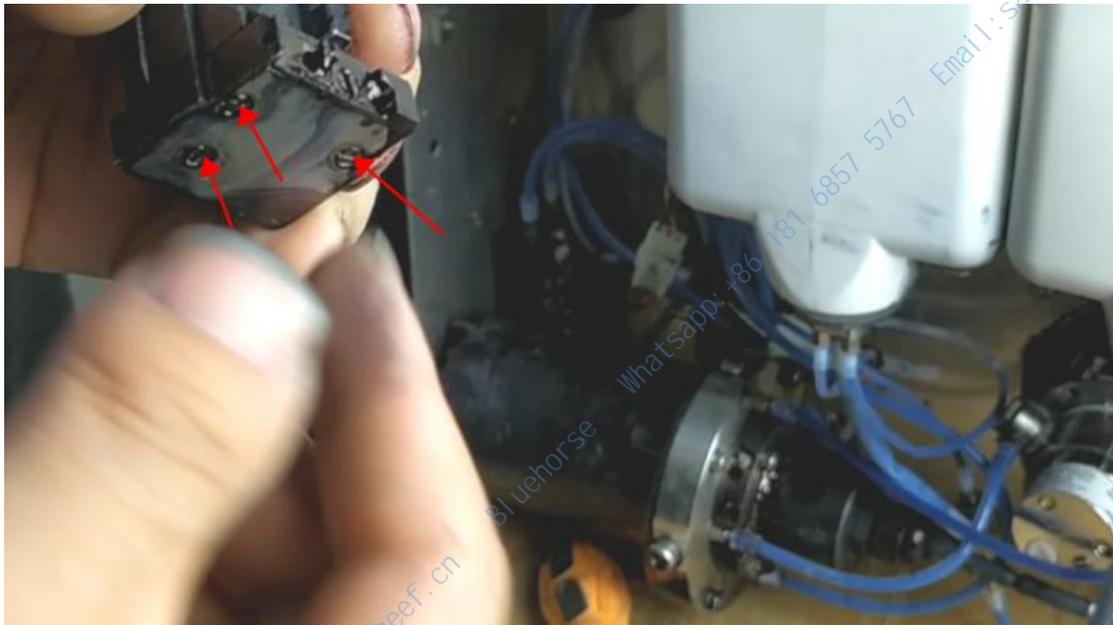
First of all, loosen the three screws by one turn:

But the three screws must be loosened first. Otherwise, when you adjust them, they are easy to break, because they are easy to deform. Once they deform, they are useless.

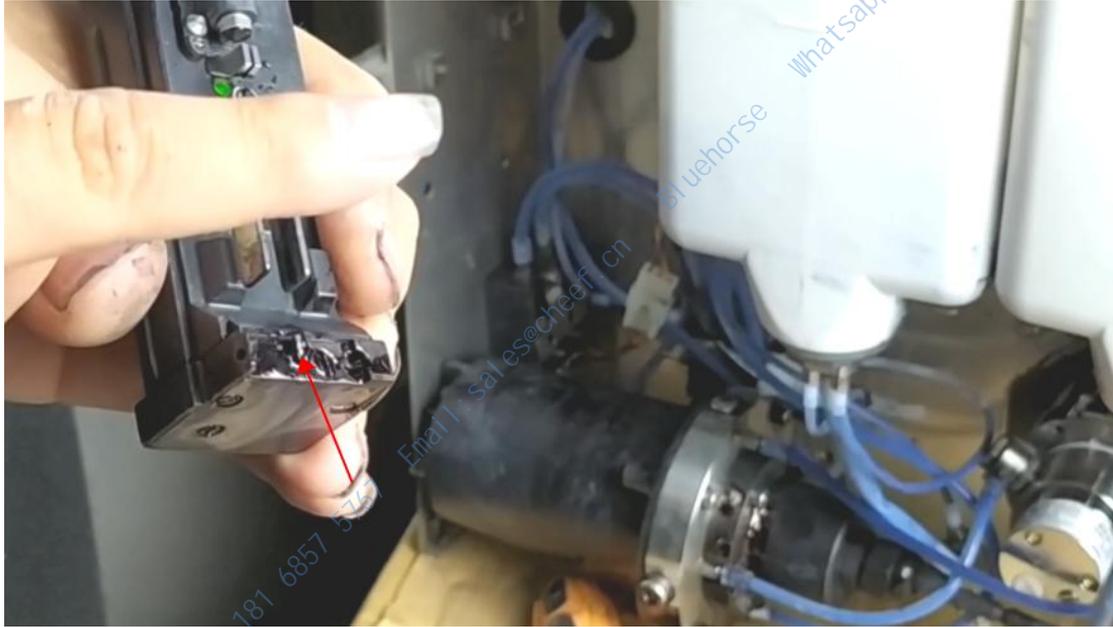
Then up and down, we can use a slotted screwdriver to raise the stainless steel rod up a little, and we can also fine tune it left and right a little:
