## Do you know what to do with ink on the Domino white ink machine charging tank?

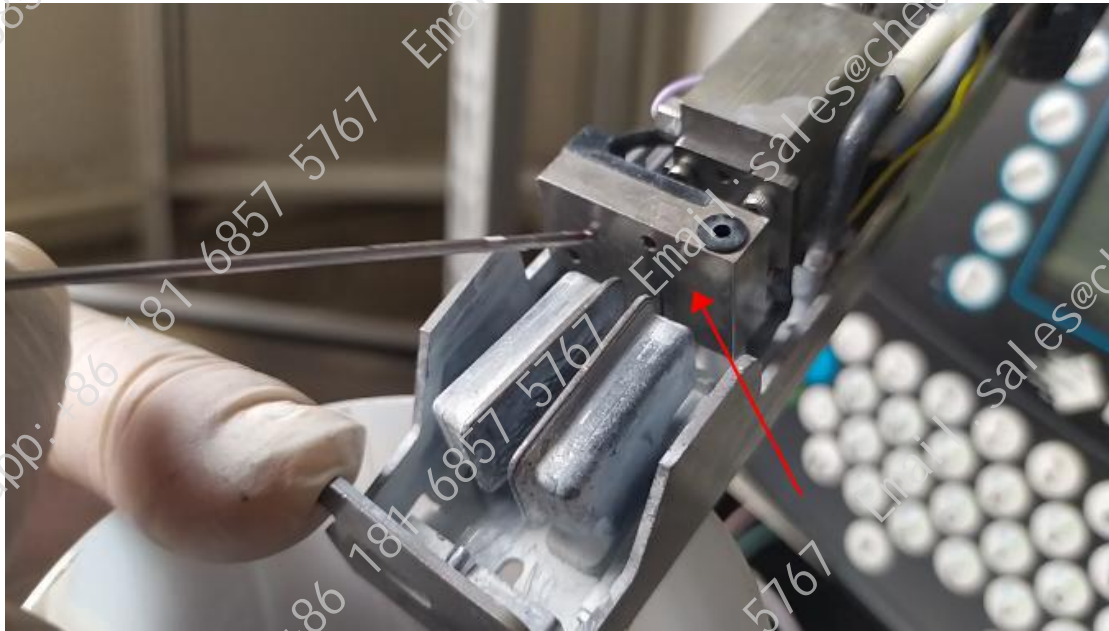
Then we look at the next fault, the common fault is the charging tank has ink, if it is reported this fault, we need to look at the charging tank here:

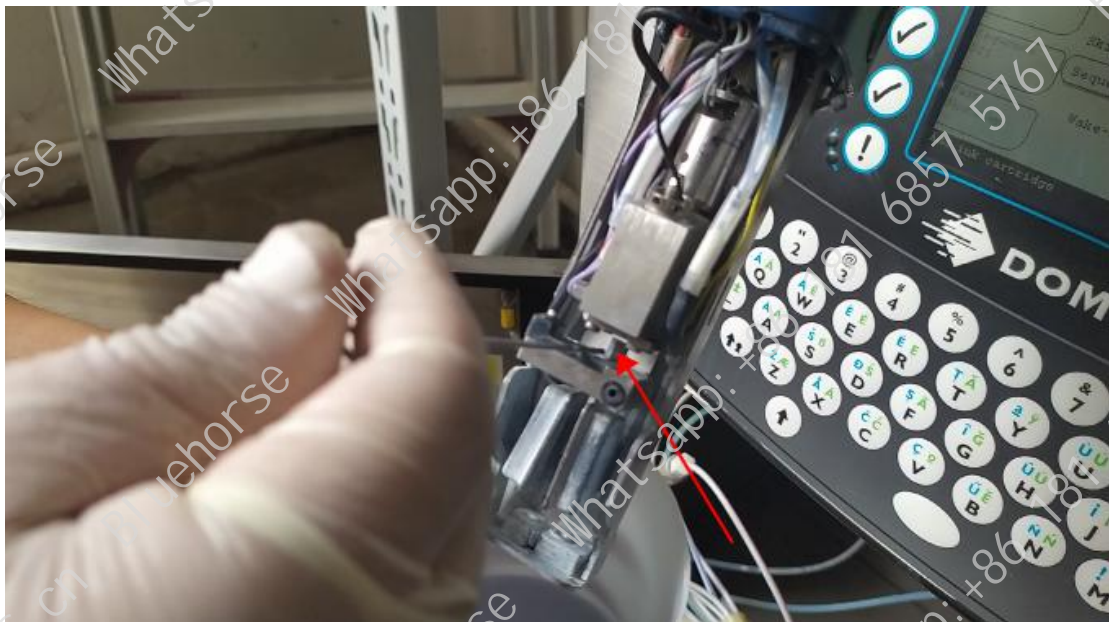
And here, is there ink:
