How to deal with recovery and high-pressure failures of the IMAJE S8 inkjet printer?

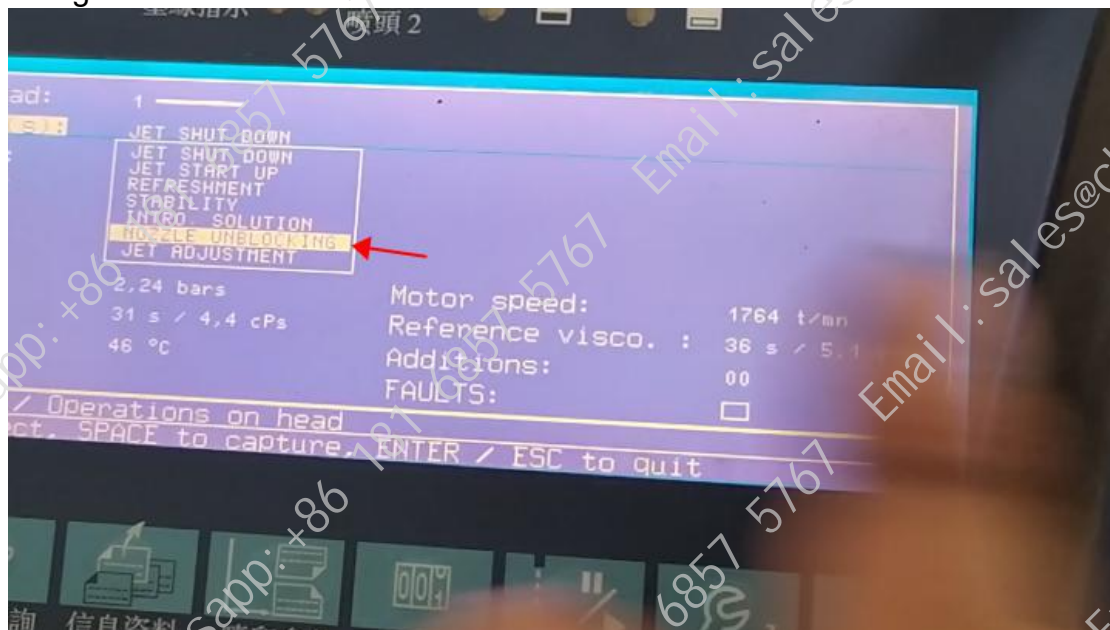
Then we need to select "nozzle dredge", and press the OK key, it will be dredged all the time:

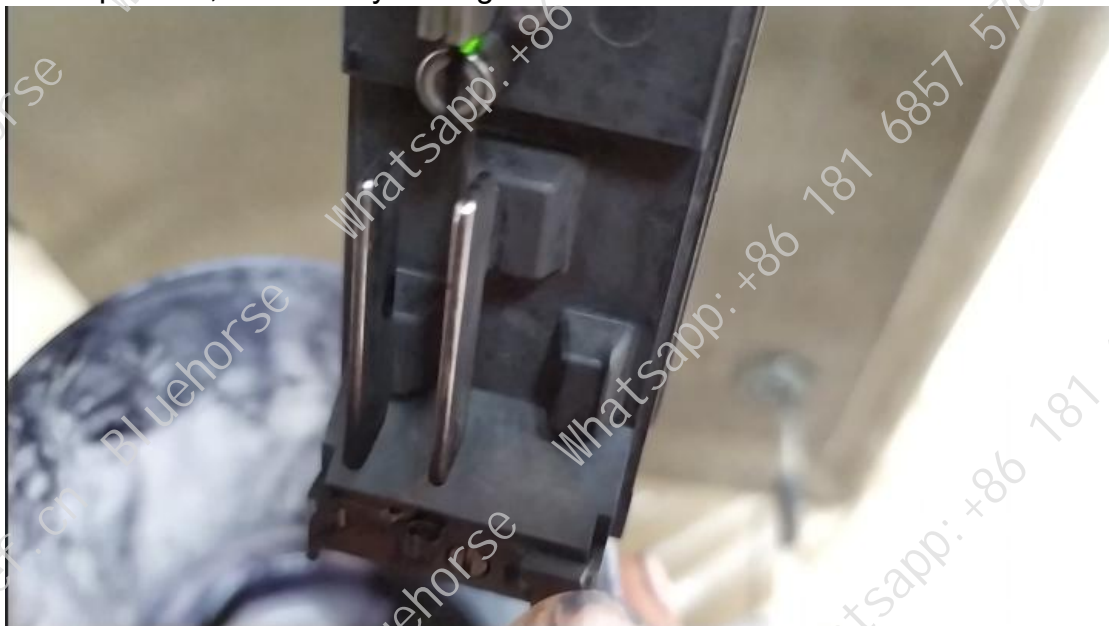
In this position, it will always dredge:

When the ink line is sprayed to the correct position of the recycling tank, we will cancel it.

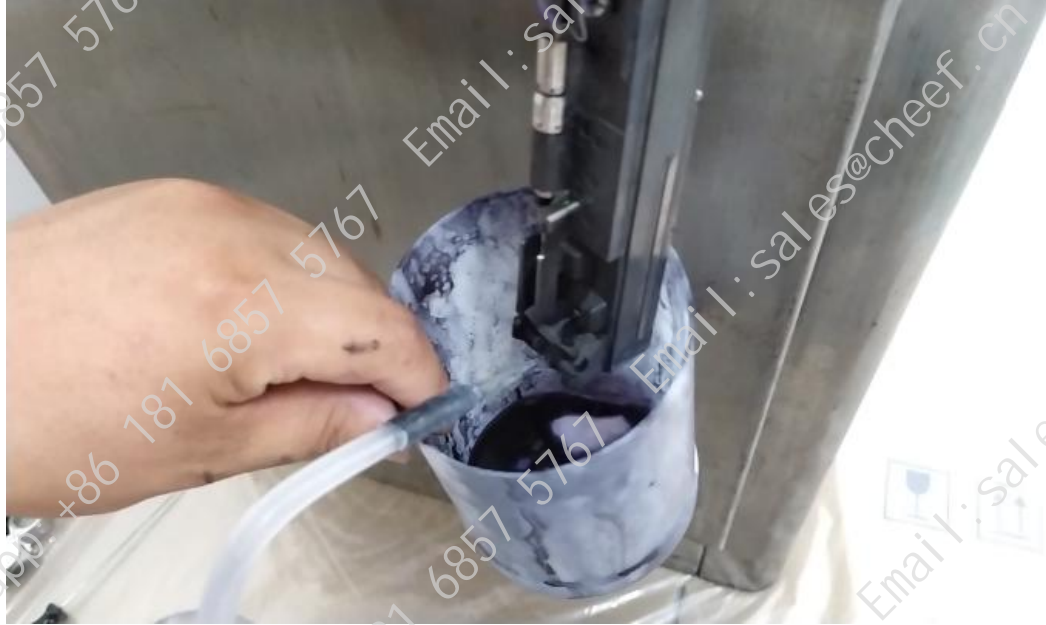
After the nozzle is dredged, we need to wash the nozzle here, and then let it air dry, or blow it dry with ear ball:

Be sure to blow dry, otherwise the high-voltage board and charging tank will give an alarm if they are wet.

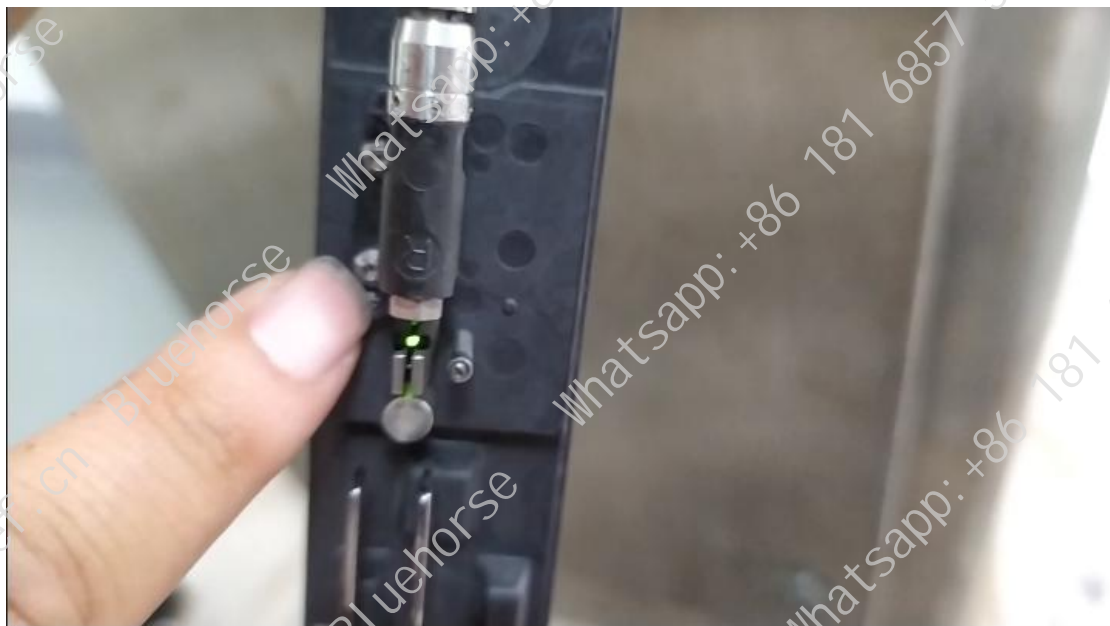
If the nozzle is unobstructed, but the ink line still deviates, we need to loosen this screw a little:

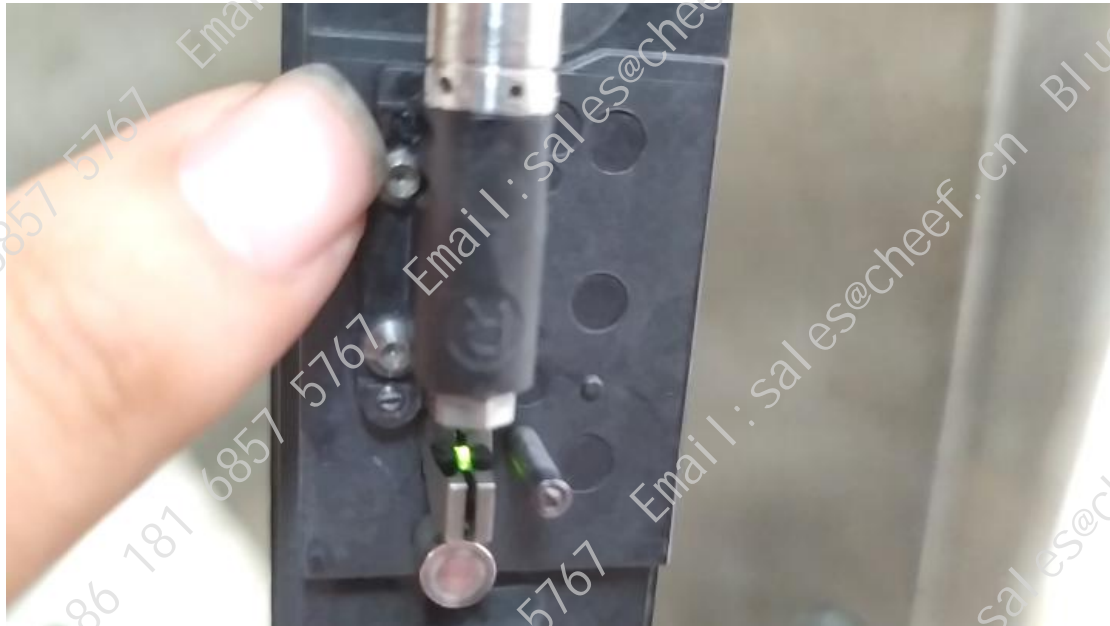
Then there's a very small slotted screw here. You need to adjust the screw hole:

In this way, we can let the ink line swing left and right until the ink line is adjusted to the correct position of the recycling tank.

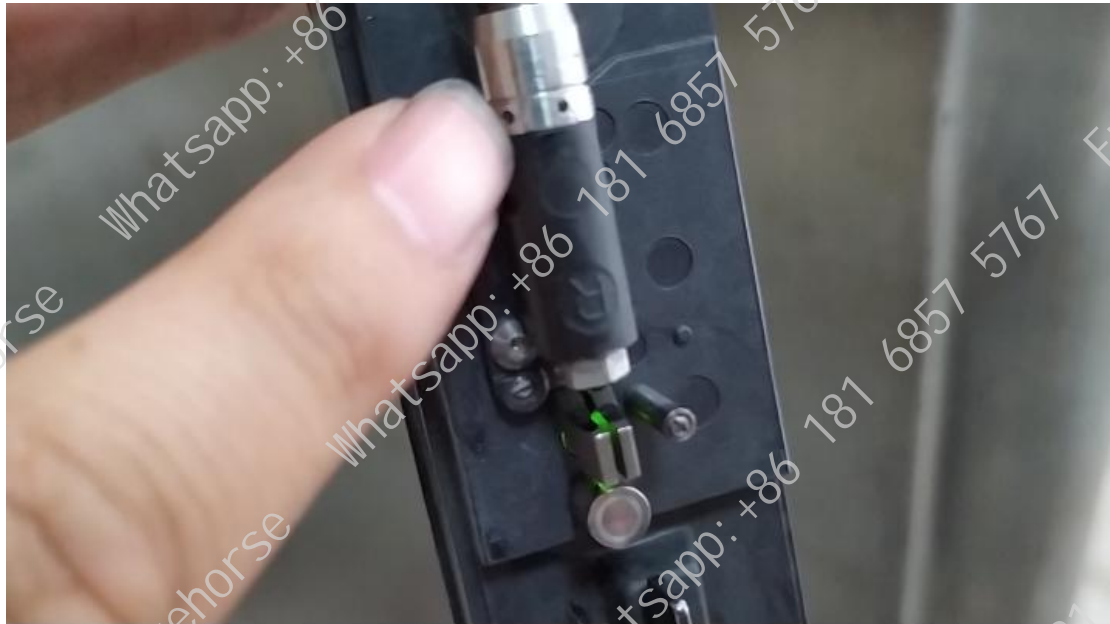
If you want to adjust up and down, we need to adjust this hole:

We use a thin steel wire to poke into the hole, and then move to the left or right, and then we can adjust the ink line height. This is a common recycling failure. If the ink line deviates, it will definitely report a recycling failure.

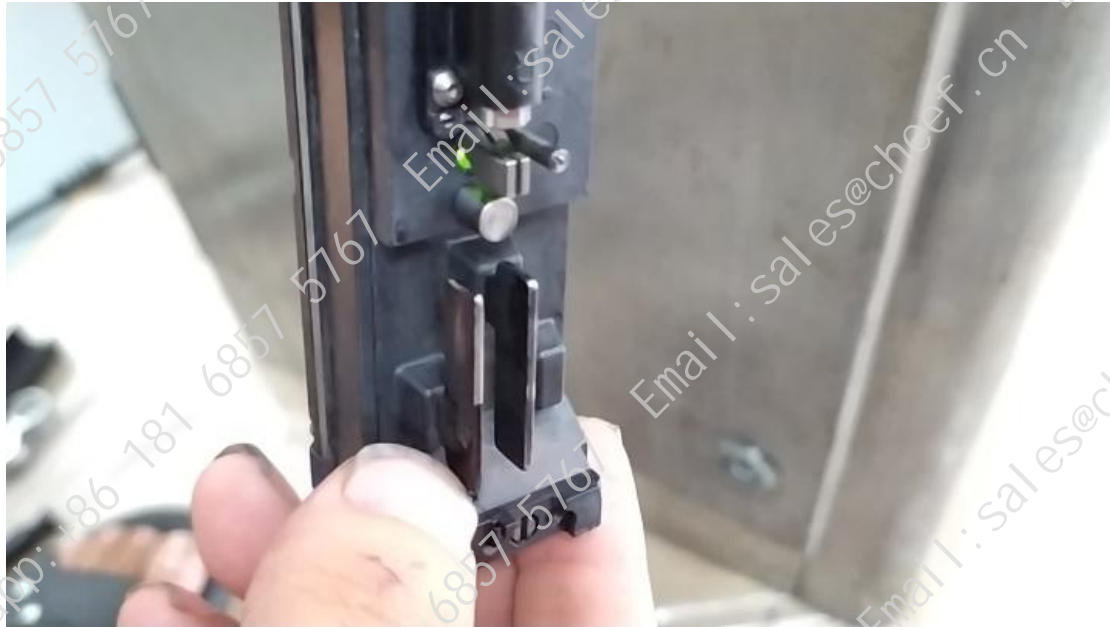
When reporting the high-voltage fault, we should check whether there is dirty ink, black ink and dry ink on the high-voltage deflector. If there is any, we should clean it:

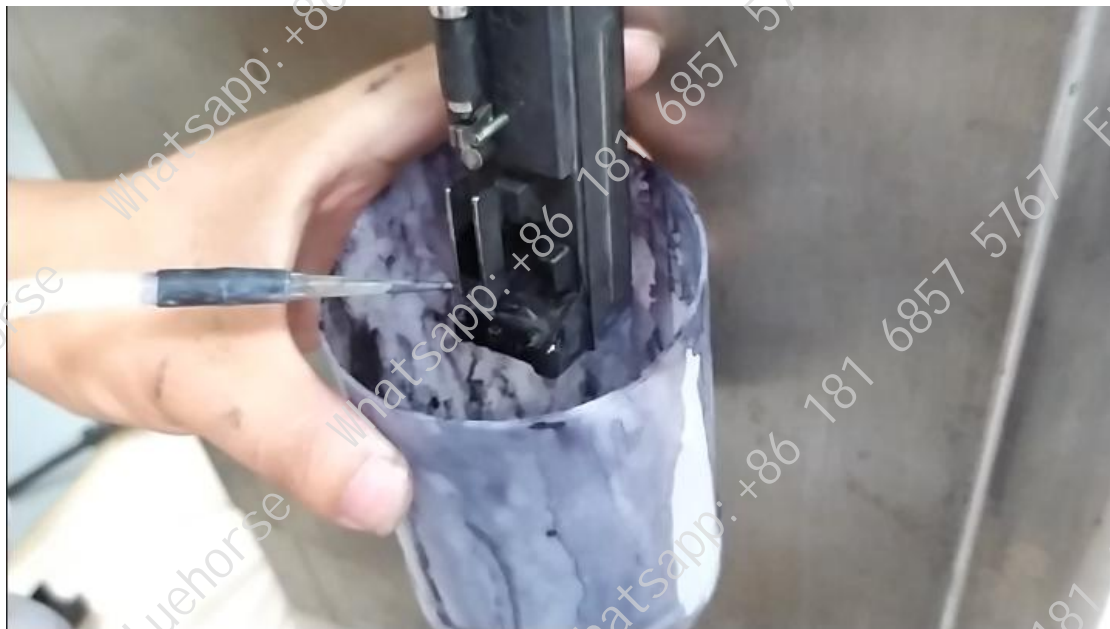
We wash it like this:

Then the high-pressure deflector must be kept dry, and it must be blown dry after washing.
